# Access Compliance Report

## Public Rights-of-Way

### (Curb Ramps)

Intersection ID: 28328	Main Street: HANWORTH_TRACE_DR	Cross Street: HIRSCH_DR	Location: S
ADA ID: DBEDE18DD5DF	Ramp Type: Perp	Initial Pass/Fail: Fail	Overall Compliance: No
Severity Score: 12.5			
Codes/Mitigation Info/Possible Solution		Field Measurements/Component Compliance

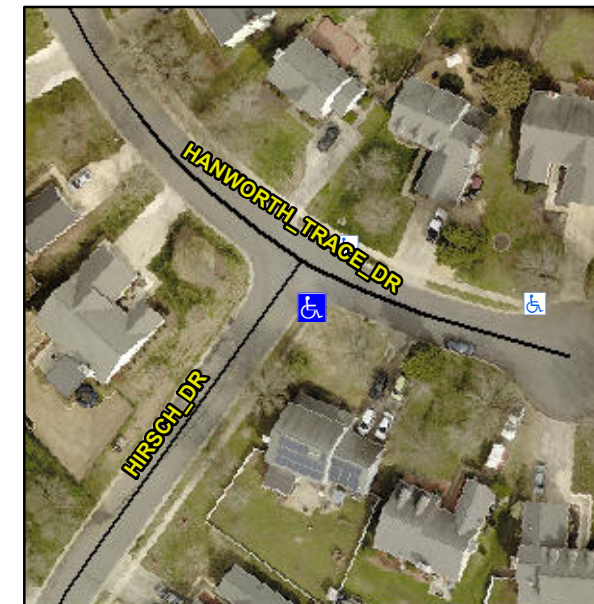
**Not Found, R304.2.2**

Compliance	Description	Data	Compliance	Description	Data
N/A	Ramp Length (in)	58.0	No	Ramp Slope (%)	11.1
Yes	Ramp Width (in)	48.0	Yes	Ramp XSlope (%)	0.1
N/A	Flare Type LT	N/A	N/A	Flare Type RT	N/A
N/A	Flare Slope LT (%)	N/A	N/A	Flare Slope RT (%)	N/A
N/A	Flare Traversable LT?	N/A	N/A	Flare Traversable RT?	N/A
N/A	Landing Length (in)	N/A	N/A	DWS Provided?	N/A
N/A	Landing Width (in)	N/A	N/A	DWS Contrast?	N/A
N/A	Landing Slope (%)	N/A	N/A	DWS Length (in)	N/A
N/A	Landing X Slope (%)	N/A	N/A	DWS Full Width?	N/A
N/A	Landing Curb? (Y/N)	N/A	N/A	DWS Offset (in)	N/A
N/A	Shared Landing?	N/A			
N/A	Gutter Ponding?	N/A	N/A	Gutter Slope (%)	N/A
N/A	Gutter Lip Ht (in)	N/A	N/A	Gutter X Slope (%)	N/A
N/A	Painted X Walk1?	No	N/A	Painted X Walk2?	N/A
	X Walk 1 Direction	To NE		X Walk 2 Direction	N/A
N/A	X Walk 1 Width (in)	N/A	N/A	X Walk 2 Width (in)	N/A
	X Walk 1 Slope (%)	4.5		X Walk 2 Slope (%)	N/A
	X Walk 1 X Slope (%)	1.8		X Walk 2 X Slope (%)	N/A

N/A	Ramp inside XWalk1?	N/A	N/A	Ramp inside XWalk2?	N/A
	Road Slope (%)	1.1	N/A	Clear Space?	N/A
	Road X Slope (%)	1.9	N/A	Clear Space to XWalk (in)	N/A
N/A	Any Obstructions?	N/A	N/A	Storm Grate/Utility Hazard?	N/A
	Obstruction Type			Storm Grate/Utility Type	
		N/A			N/A
			Yes	Surface Condition? (G/P)	Good

**Remove & Replace Entire Ramp.**
