Access Compliance Report

Public Rights-of-Way

(Curb Ramps)

| Intersection ID: 16751 | Main Street: PRINCETON_AV | Cross Street: QUEENS_RD_WEST | Location: NW |

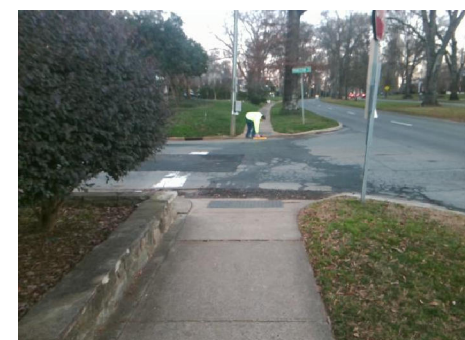
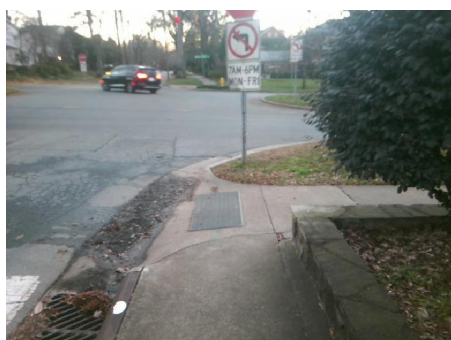
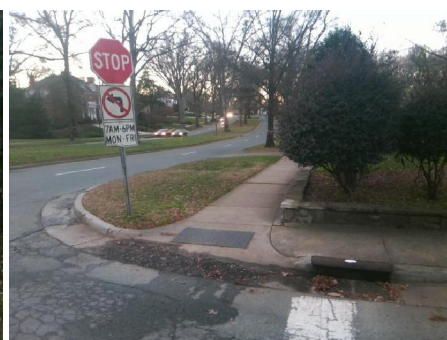
| ADA ID: DBF76BBCF352 | Ramp Type: Directional1 | Initial Pass/Fail: Fail | Overall Compliance: No |
| Severity Score: 26.25 | | | |

| Compliance | Description | Data | Compliance | Description | Data |
|---|---|---|---|---|---|
| No | Ramp XSlope (%) | 2.2 | | | |
| N/A | Gutter Ponding? | Yes | N/A | Gutter Slope (%) | N/A |

Possible Solutions:

Remove & Replace Entire Ramp.

R304.5.3
