Access Compliance Report

Public Rights-of-Way

(Curb Ramps)

Intersection ID: 10674	Main Street: E_W_T_HARRIS_BV	Cross Street: MARKWAY_DR	Location: NE
ADA ID: DBFADC009DCA	Ramp Type: PerpDiag	Initial Pass/Fail: Fail	Overall Compliance: No
Severity Score: 12.5			
Codes/Mitigation Info/Possible Solution		Field Measurements/Component Compliance

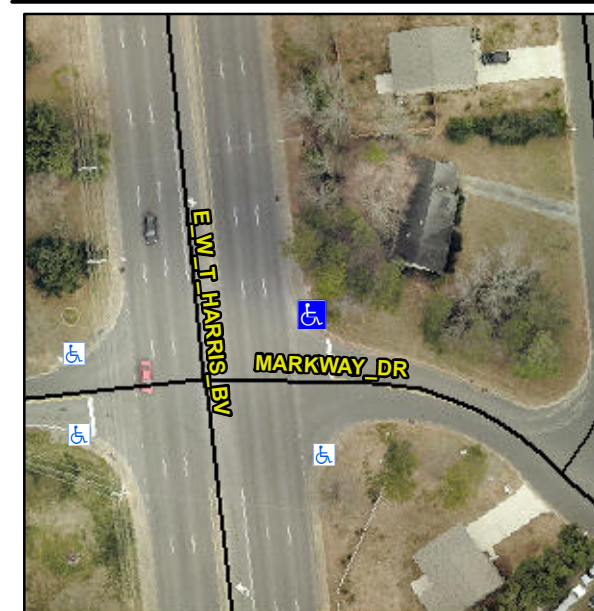
Compliance	Description	Data	Compliance	Description	Data
N/A	Ramp Length (in)	61.5	No	Ramp Slope (%)	9.8
Yes	Ramp Width (in)	48.0	Yes	Ramp XSlope (%)	0.2
N/A	Flare Type LT	N/A	N/A	Flare Type RT	N/A
N/A	Flare Slope LT (%)	N/A	N/A	Flare Slope RT (%)	N/A
N/A	Flare Traversable LT?	N/A	N/A	Flare Traversable RT?	N/A
N/A	Landing Length (in)	N/A	N/A	DWS Provided?	N/A
N/A	Landing Width (in)	N/A	N/A	DWS Contrast?	N/A
N/A	Landing Slope (%)	N/A	N/A	DWS Length (in)	N/A
N/A	Landing X Slope (%)	N/A	N/A	DWS Full Width?	N/A
N/A	Landing Curb? (Y/N)	N/A	N/A	DWS Offset (in)	N/A
N/A	Shared Landing?	N/A			
N/A	Gutter Ponding?	Yes	N/A	Gutter Slope (%)	N/A
N/A	Gutter Lip Ht (in)	N/A	N/A	Gutter X Slope (%)	N/A
N/A	Painted X Walk1?	No	N/A	Painted X Walk2?	No
	X Walk 1 Direction	To W		X Walk 2 Direction	To S
N/A	X Walk 1 Width (in)	N/A	N/A	X Walk 2 Width (in)	N/A
	X Walk 1 Slope (%)	2.2		X Walk 2 Slope (%)	1.7
	X Walk 1 X Slope (%)	0.8		X Walk 2 X Slope (%)	0.0

N/A	Ramp inside XWalk1?	N/A	N/A	Ramp inside XWalk2?	N/A
	Road Slope (%)	1.6	N/A	Clear Space?	N/A
	Road X Slope (%)	1.8	N/A	Clear Space to XWalk (in)	N/A
N/A	Any Obstructions?	N/A	N/A	Storm Grate/Utility Hazard?	N/A
	Obstruction Type			Storm Grate/Utility Type	
		N/A			N/A
		Yes		Surface Condition? (G/P)	Good

Possible Solutions:

Remove & Replace Curb Ramp With Two New Directional Ramps or Equivalent.

Not Found, R304.2.2
