# Access Compliance Report

## Public Rights-of-Way

### (Curb Ramps)

Intersection ID: 14468	Main Street: E_TREMONT_AV	Cross Street: EUCLID_AV	Location: W
ADA ID: DBFDBDAAD165	Ramp Type: PerpDiag	Initial Pass/Fail: Fail	Overall Compliance: No
Severity Score: 37.5			
Codes/Mitigation Info/Possible Solution		Field Measurements/Component Compliance

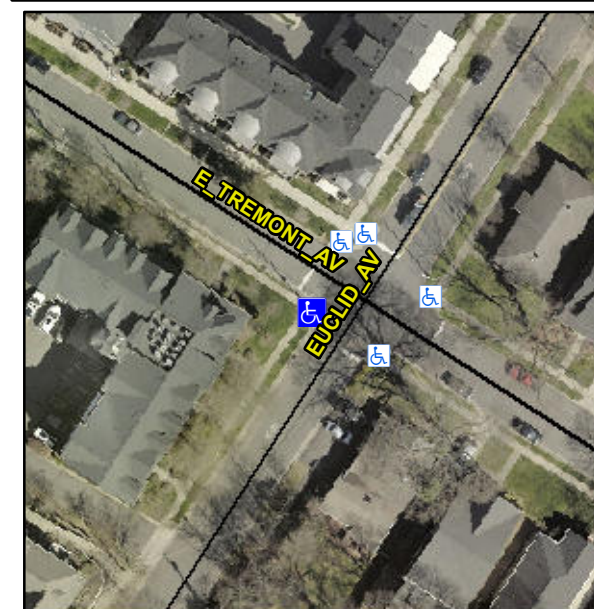
**Not Found, R304.2.2, R304.5.3**

Compliance	Description	Data	Compliance	Description	Data
N/A	Ramp Length (in)	104.0	No	Ramp Slope (%)	17.1
Yes	Ramp Width (in)	48.0	No	Ramp XSlope (%)	5.3
N/A	Flare Type LT	N/A	N/A	Flare Type RT	N/A
N/A	Flare Slope LT (%)	N/A	N/A	Flare Slope RT (%)	N/A
N/A	Flare Traversable LT?	N/A	N/A	Flare Traversable RT?	N/A
N/A	Landing Length (in)	N/A	N/A	DWS Provided?	N/A
N/A	Landing Width (in)	N/A	N/A	DWS Contrast?	N/A
N/A	Landing Slope (%)	N/A	N/A	DWS Length (in)	N/A
N/A	Landing X Slope (%)	N/A	N/A	DWS Full Width?	N/A
N/A	Landing Curb? (Y/N)	N/A	N/A	DWS Offset (in)	N/A
N/A	Shared Landing?	N/A			
N/A	Gutter Ponding?	N/A	N/A	Gutter Slope (%)	N/A
N/A	Gutter Lip Ht (in)	1.0	N/A	Gutter X Slope (%)	N/A
N/A	Painted X Walk1?	No	N/A	Painted X Walk2?	No
	X Walk 1 Direction	To SE		X Walk 2 Direction	To NE
N/A	X Walk 1 Width (in)	N/A	N/A	X Walk 2 Width (in)	N/A
	X Walk 1 Slope (%)	1.4		X Walk 2 Slope (%)	1.0
	X Walk 1 X Slope (%)	1.9		X Walk 2 X Slope (%)	2.4

N/A	Ramp inside XWalk1?	N/A	N/A	Ramp inside XWalk2?	N/A
	Road Slope (%)	0.5	N/A	Clear Space?	N/A
	Road X Slope (%)	1.6	N/A	Clear Space to XWalk (in)	N/A
N/A	Any Obstructions?	N/A	N/A	Storm Grate/Utility Hazard?	N/A
	Obstruction Type			Storm Grate/Utility Type	
		N/A			N/A
		Yes		Surface Condition? (G/P)	Good

**Remove & Replace Curb Ramp With Two New Directional Ramps or Equivalent.**
