Access Compliance Report

Public Rights-of-Way

(Curb Ramps)

Intersection ID: 9799	Main Street: HERRIN_AV	Cross Street: WARP_ST	Location: NE
ADA ID: DC0336E28B21	Ramp Type: Directional1	Initial Pass/Fail: Fail	Overall Compliance: No
			Severity Score: 36.25

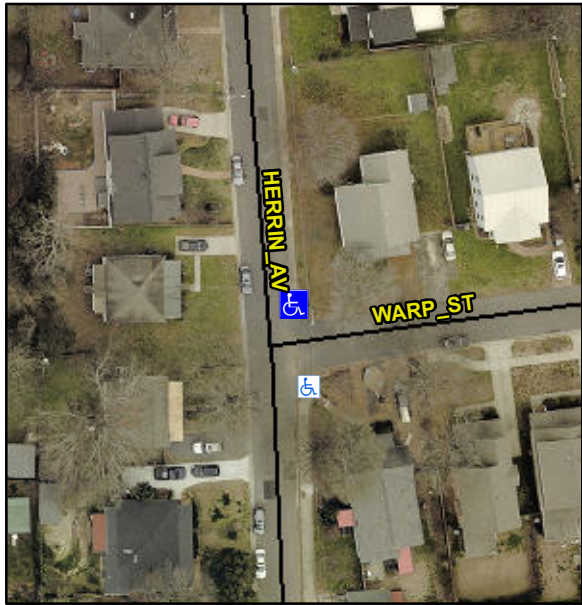
Possible Solutions:		Compliance			Description			Data		
	Remove & Replace Entire Ramp.		N/A	Ramp Length (in)		36.0	N/A	Grade Break?		N/A	
			No	Ramp Width (in)		38.0	N/A	Grade Break Slope (%)		0.0	
			Yes	Ramp Slope (%)		6.6	N/A	Grade Break XSlope (%)		0.0	
			No	Ramp XSlope (%)		6.7					
			N/A	Flare Type LT		N/A	N/A	Flare Type RT		N/A	
			N/A	Flare Slope LT (%)		N/A	N/A	Flare Slope RT (%)		0.0	
			N/A	Flare Traversable LT?		N/A	N/A	Flare Traversable RT?		N/A	
			N/A	Landing Length (in)		0.0	N/A	DWS Provided?		N/A	
			N/A	Landing Width (in)		0.0	N/A	DWS Contrast?		N/A	
		N/A	Landing Slope (%)		0.0	N/A	DWS Length (in)		N/A		
		N/A	Landing X Slope (%)		0.0	N/A	DWS Full Width?		N/A		
		N/A	Landing Curb? (Y/N)		N/A	N/A	DWS Offset LT (in)		N/A		
		N/A	Shared Landing?		N/A	N/A	DWS Offset RT (in)		N/A		
		N/A	Gutter Ponding?		0.0	N/A	Gutter Slope (%)		N/A

N/A	Gutter Lip Ht (in)		0.0	N/A	Gutter X Slope (%)		N/A		
		N/A	Painted X Walk1?		No		Road Slope (%)		5.9		
			X Walk 1 Direction		To SE		Road X Slope (%)		5.1		
			X Walk 1 Width (in)		N/A		Clear Space?		N/A		
			X Walk 1 Slope (%)		5.9	N/A	Clear Space to XWalk (in)		N/A		
			X Walk 1 X Slope (%)		5.1	N/A	Storm Grate/Utility Hazard?		N/A		
		N/A	Ramp inside XWalk1?		N/A		Storm Grate/Utility Type				
		N/A	Any Obstructions?		N/A				N/A		
			Obstruction Type			No	Surface Condition? (G/P)		Poor		
						N/A	Curb Slope (%)		N/A		
						</
