Access Compliance Report

Public Rights-of-Way

(Curb Ramps)

Intersection ID: 13551	Main Street: WAGON_OAK_RD	Cross Street: HOBBS_HILL_DR	Location: NE
ADA ID: DC03D7DCE3E3	Ramp Type: BlendTrans1	Initial Pass/Fail: Pass	Overall Compliance: No
		Severity Score: 0

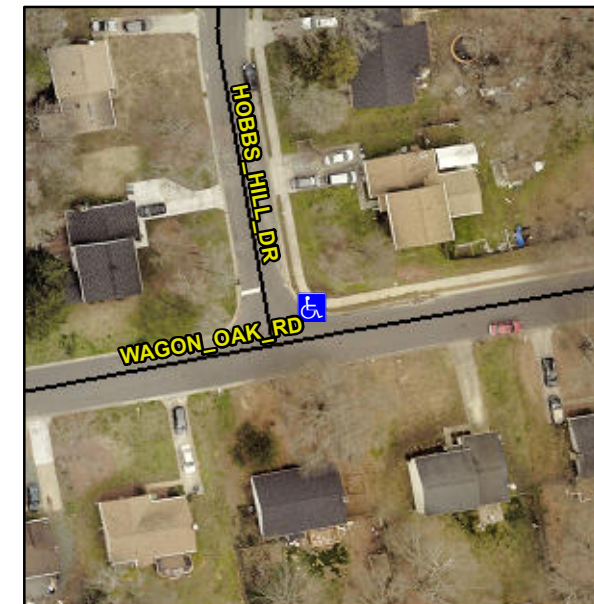
Compliance	Description	Data	Compliance	Description	Data
N/A	Ramp Length (in)	27.0	Yes	BlendTrans Slope (%)	3.2
Yes	Ramp Width (in)	48.0	Yes	BlendTrans XSlope (%)	0.7
N/A	Flare Type LT	Sloped	N/A	Flare Type RT	Sloped
N/A	Flare Slope LT (%)	1.8	N/A	Flare Slope RT (%)	0.2
N/A	Flare Traversable LT?	No	N/A	Flare Traversable RT?	No
Yes	Landing Length (in)	58.0	Yes	DWS Provided?	Yes
Yes	Landing Width (in)	71.0	Yes	DWS Contrast?	Yes
No	Landing Slope (%)	2.8	Yes	DWS Length (in)	24.0
Yes	Landing X Slope (%)	1.1	Yes	DWS Full Width?	Yes
N/A	Landing Curb? (Y/N)	No	No	DWS Offset (in)	3.0
N/A	Shared Landing?	No			
Yes	Gutter Ponding?	No	Yes	Gutter Slope (%)	1.1
Yes	Gutter Lip Ht (in)	0.0	Yes	Gutter X Slope (%)	0.4
N/A	Painted X Walk1?	No	N/A	Painted X Walk2?	No
	X Walk 1 Direction	To W		X Walk 2 Direction	To S
	X Walk 1 Width (in)	N/A		X Walk 2 Width (in)	N/A
	X Walk 1 Slope (%)	1.0		X Walk 2 Slope (%)	1.9
	X Walk 1 X Slope (%)	0.7		X Walk 2 X Slope (%)	1.1

N/A	Ramp inside XWalk1?	N/A	N/A	Ramp inside XWalk2?	N/A
	Road Slope (%)	2.2		Clear Space?	Yes
	Road X Slope (%)	5.2	N/A	Clear Space to XWalk (in)	N/A
Yes	Any Obstructions?	No	Yes	Storm Grate/Utility Hazard?	No
	Obstruction Type			Storm Grate/Utility Type	
		N/A			N/A
			Yes	Surface Condition? (G/P)	Good
			No	Curb Slope (%)	10.4

Remove & Replace Curb Ramp With Two New Directional Ramps or Equivalent.
