# Access Compliance Report

## Public Rights-of-Way

| Intersection ID: 16755 | Main Street: DICKINSON_PL | Cross Street: PRINCETON_AV | Location: S |
| ADA ID: DC09B1C5AF85 | Ramp Type: BlendTrans1 | Initial Pass/Fail: Pass | Overall Compliance: No |

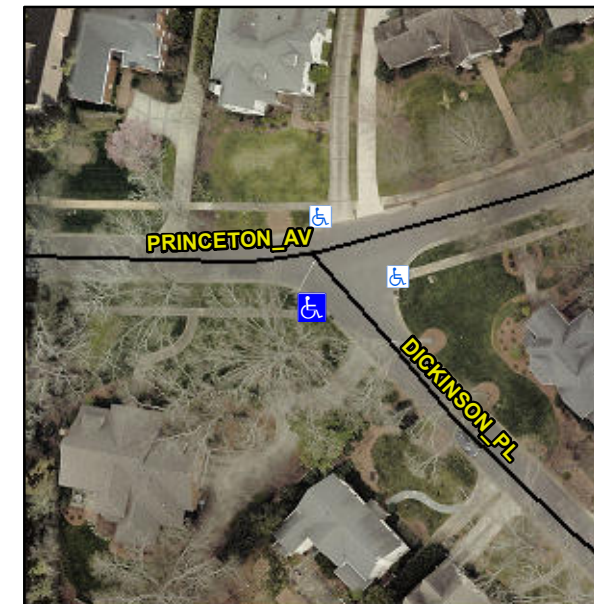
**ASP LIP 0.5**

**Not Found, R304.5.3, R305.2, R304.5.4**

| Compliance | Description | Data | Compliance | Description | Data |
|---|---|---|---|---|---|
| Yes | Ramp Width (in) | 53.5 | No | BlendTrans XSlope (%) | 3.0 |
| No | Landing X Slope (%) | 3.5 | Yes | DWS Full Width? | Yes |
| N/A | Landing Curb? (Y/N) | No | No | DWS Offset (in) | 4.0 |
| Yes | Gutter Ponding? | No | No | Gutter Slope (%) | 9.5 |
| | | | No | Curb Slope (%) | 17.6 |

**Remove & Replace Curb Ramp With Two New Directional Ramps or Equivalent. Remove & Replace Gutter.**

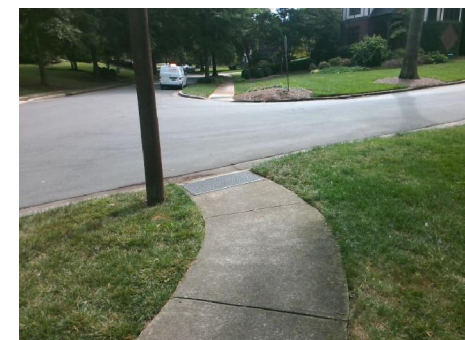
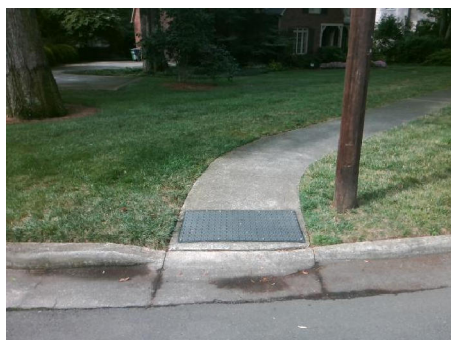
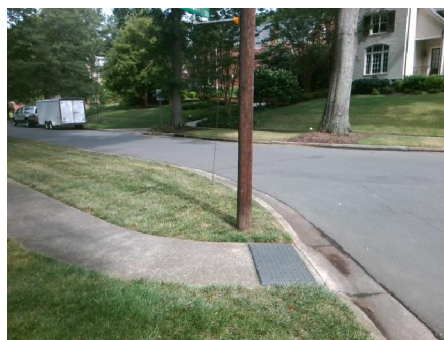
Street 1 Name DICKINSON PL  
 Stop Condition-Street 1 StopSign  
 Street 2 Name PRINCETON AV  
 Stop Condition-Street 2 None
