Access Compliance Report

Public Rights-of-Way

(Curb Ramps)

Intersection ID: 45983	Main Street: MASON_MILL_PL	Cross Street: WOODBOURNE_LN	Location: NE
ADA ID: DC0B000B0F8C	Ramp Type: PerpDiag	Initial Pass/Fail: Fail	Overall Compliance: No
Severity Score: 21.25			
Codes/Mitigation Info/Possible Solution		Field Measurements/Component Compliance

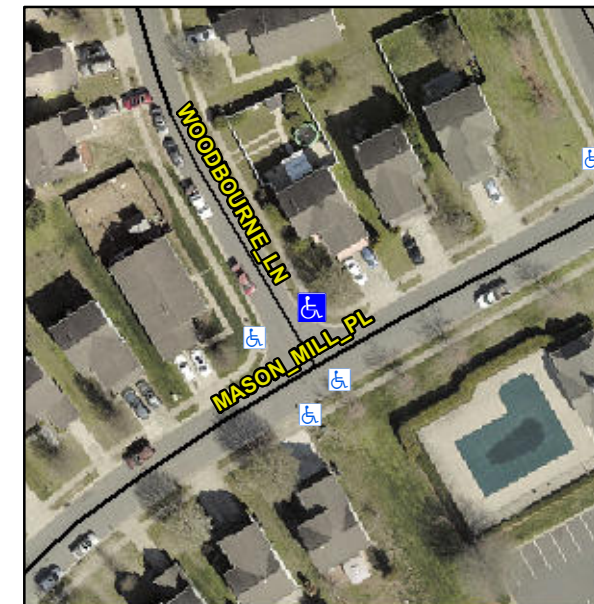
Compliance	Description	Data	Compliance	Description	Data
N/A	Ramp Length (in)	47.0	No	Ramp Slope (%)	8.8
No	Ramp Width (in)	39.5	Yes	Ramp XSlope (%)	0.3
N/A	Flare Type LT	N/A	N/A	Flare Type RT	N/A
N/A	Flare Slope LT (%)	N/A	N/A	Flare Slope RT (%)	N/A
N/A	Flare Traversable LT?	N/A	N/A	Flare Traversable RT?	N/A
N/A	Landing Length (in)	N/A	N/A	DWS Provided?	N/A
N/A	Landing Width (in)	N/A	N/A	DWS Contrast?	N/A
N/A	Landing Slope (%)	N/A	N/A	DWS Length (in)	N/A
N/A	Landing X Slope (%)	N/A	N/A	DWS Full Width?	N/A
N/A	Landing Curb? (Y/N)	N/A	N/A	DWS Offset (in)	N/A
N/A	Shared Landing?	N/A			
N/A	Gutter Ponding?	N/A	N/A	Gutter Slope (%)	N/A
N/A	Gutter Lip Ht (in)	N/A	N/A	Gutter X Slope (%)	N/A
N/A	Painted X Walk1?	No	N/A	Painted X Walk2?	No
	X Walk 1 Direction	To W		X Walk 2 Direction	To S
N/A	X Walk 1 Width (in)	N/A	N/A	X Walk 2 Width (in)	N/A
	X Walk 1 Slope (%)	2.3		X Walk 2 Slope (%)	2.2
	X Walk 1 X Slope (%)	0.0		X Walk 2 X Slope (%)	1.2

N/A	Ramp inside XWalk1?	N/A	N/A	Ramp inside XWalk2?	N/A
	Road Slope (%)	0.4	N/A	Clear Space?	N/A
	Road X Slope (%)	0.2	N/A	Clear Space to XWalk (in)	N/A
N/A	Any Obstructions?	N/A	N/A	Storm Grate/Utility Hazard?	N/A
	Obstruction Type			Storm Grate/Utility Type	
		N/A			N/A
			Yes	Surface Condition? (G/P)	Good

Possible Solutions:

Remove & Replace Curb Ramp With Two New Directional Ramps or Equivalent.

R304.5.1, R304.2.2
