Access Compliance Report

Public Rights-of-Way

(Curb Ramps)

Intersection ID: 3537	Main Street: MT_ISLE_HARBOR_DR	Cross Street: SHIMMERING_LAKE_DR	Location: S
ADA ID: DC13F409A903	Ramp Type: Perp	Initial Pass/Fail: Fail	Overall Compliance: No
Severity Score: 58.75			
Codes/Mitigation Info/Possible Solution		Field Measurements/Component Compliance

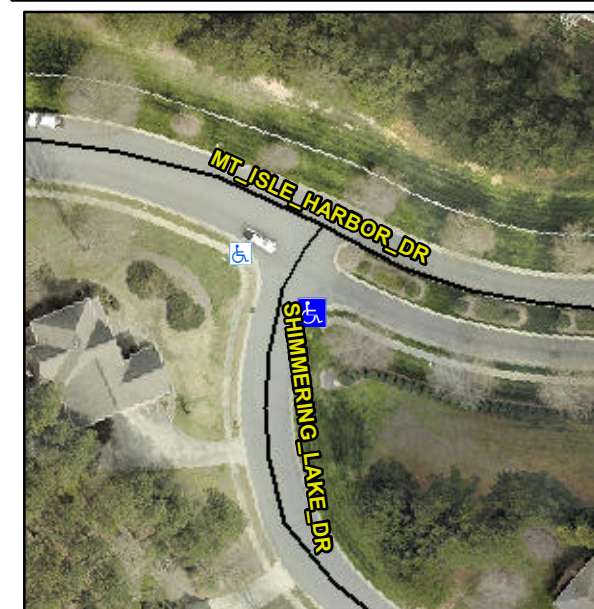
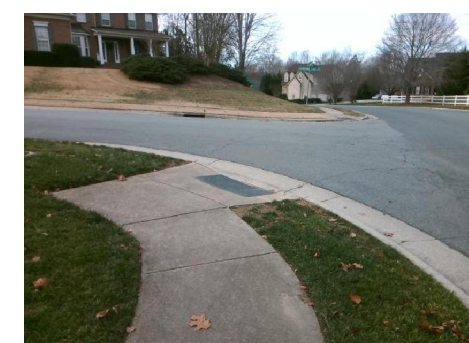
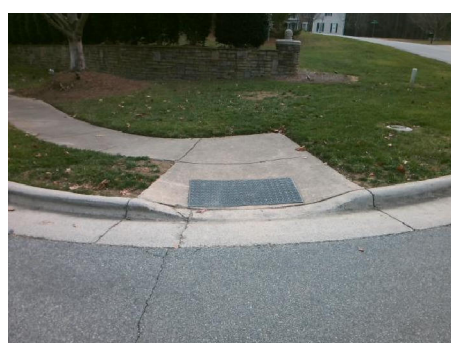
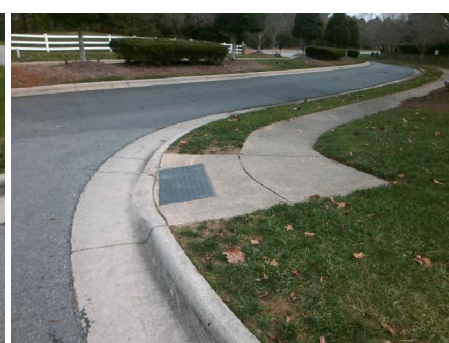
Compliance	Description	Data	Compliance	Description	Data
N/A	Ramp Length (in)	46.0	No	Ramp Slope (%)	12.0
No	Ramp Width (in)	45.0	No	Ramp XSlope (%)	7.0
N/A	Flare Type LT	N/A	N/A	Flare Type RT	N/A
N/A	Flare Slope LT (%)	N/A	N/A	Flare Slope RT (%)	N/A
N/A	Flare Traversable LT?	N/A	N/A	Flare Traversable RT?	N/A
N/A	Landing Length (in)	N/A	N/A	DWS Provided?	N/A
N/A	Landing Width (in)	N/A	N/A	DWS Contrast?	N/A
N/A	Landing Slope (%)	N/A	N/A	DWS Length (in)	N/A
N/A	Landing X Slope (%)	N/A	N/A	DWS Full Width?	N/A
N/A	Landing Curb? (Y/N)	N/A	N/A	DWS Offset (in)	N/A
N/A	Shared Landing?	N/A			
N/A	Gutter Ponding?	N/A	N/A	Gutter Slope (%)	N/A
N/A	Gutter Lip Ht (in)	N/A	N/A	Gutter X Slope (%)	N/A
N/A	Painted X Walk1?	No	N/A	Painted X Walk2?	N/A
	X Walk 1 Direction	To NW		X Walk 2 Direction	N/A
N/A	X Walk 1 Width (in)	N/A	N/A	X Walk 2 Width (in)	N/A
	X Walk 1 Slope (%)	0.4		X Walk 2 Slope (%)	N/A
	X Walk 1 X Slope (%)	4.0		X Walk 2 X Slope (%)	N/A

N/A	Ramp inside XWalk1?	N/A	N/A	Ramp inside XWalk2?	N/A
	Road Slope (%)	N/A	N/A	Clear Space?	N/A
	Road X Slope (%)	N/A	N/A	Clear Space to XWalk (in)	N/A
N/A	Any Obstructions?	N/A	N/A	Storm Grate/Utility Hazard?	N/A
	Obstruction Type			Storm Grate/Utility Type	
		N/A			N/A
			Yes	Surface Condition? (G/P)	Good

Possible Solutions:

Remove & Replace Entire Ramp.
