# Access Compliance Report

## Public Rights-of-Way

### (Curb Ramps)

Intersection ID: 48952	Main Street: BREVERA_CR	Cross Street: BONROI_AV	Location:	N
ADA ID: DC1A7C628213	Ramp Type: Perp	Initial Pass/Fail: Fail	Overall Compliance: No	Severity Score: 21.25
Codes/Mitigation Info/Possible Solution		Field Measurements/Component Compliance

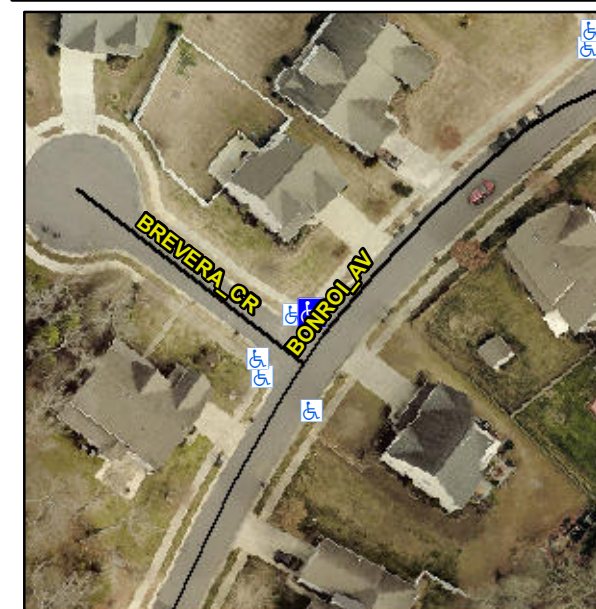
**Not Found, R304.5.1, R304.2.2**

Compliance	Description	Data	Compliance	Description	Data
N/A	Ramp Length (in)	47.0	No	Ramp Slope (%)	8.5
No	Ramp Width (in)	47.5	Yes	Ramp XSlope (%)	0.1
N/A	Flare Type LT	N/A	N/A	Flare Type RT	N/A
N/A	Flare Slope LT (%)	N/A	N/A	Flare Slope RT (%)	N/A
N/A	Flare Traversable LT?	N/A	N/A	Flare Traversable RT?	N/A
N/A	Landing Length (in)	N/A	N/A	DWS Provided?	N/A
N/A	Landing Width (in)	N/A	N/A	DWS Contrast?	N/A
N/A	Landing Slope (%)	N/A	N/A	DWS Length (in)	N/A
N/A	Landing X Slope (%)	N/A	N/A	DWS Full Width?	N/A
N/A	Landing Curb? (Y/N)	N/A	N/A	DWS Offset (in)	N/A
N/A	Shared Landing?	N/A			
N/A	Gutter Ponding?	N/A	N/A	Gutter Slope (%)	N/A
N/A	Gutter Lip Ht (in)	N/A	N/A	Gutter X Slope (%)	N/A
N/A	Painted X Walk1?	No	N/A	Painted X Walk2?	N/A
	X Walk 1 Direction	To SE		X Walk 2 Direction	N/A
N/A	X Walk 1 Width (in)	N/A	N/A	X Walk 2 Width (in)	N/A
	X Walk 1 Slope (%)	1.3		X Walk 2 Slope (%)	N/A
	X Walk 1 X Slope (%)	0.7		X Walk 2 X Slope (%)	N/A

**Remove & Replace Entire Ramp.**

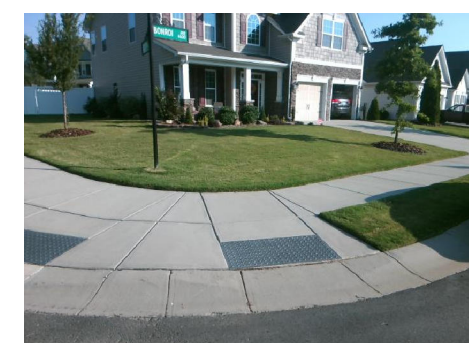
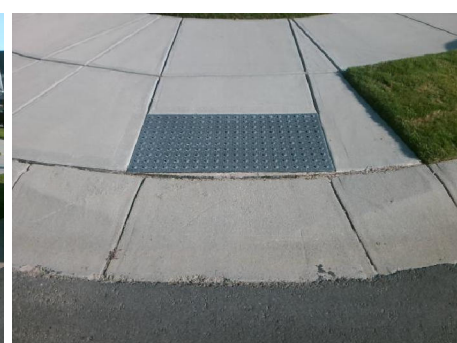
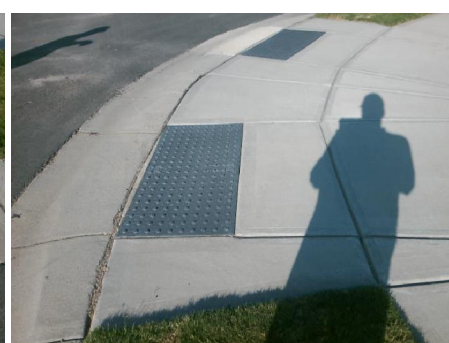
N/A	Ramp inside XWalk1?	N/A	N/A	Ramp inside XWalk2?	N/A
	Road Slope (%)	N/A	N/A	Clear Space?	N/A
	Road X Slope (%)	N/A	N/A	Clear Space to XWalk (in)	N/A
N/A	Any Obstructions?	N/A	N/A	Storm Grate/Utility Hazard?	N/A
	Obstruction Type			Storm Grate/Utility Type	
		N/A			N/A
			Yes	Surface Condition? (G/P)	Good
