# Access Compliance Report

## Public Rights-of-Way (Curb Ramps)

Intersection ID: 10017280	Main Street: SUNSET_RD	Cross Street: N/A	Location: S
ADA ID: DC1C340C84D9	Ramp Type: Directional1	Initial Pass/Fail: Fail	Overall Compliance: No
		Severity Score: 12.5

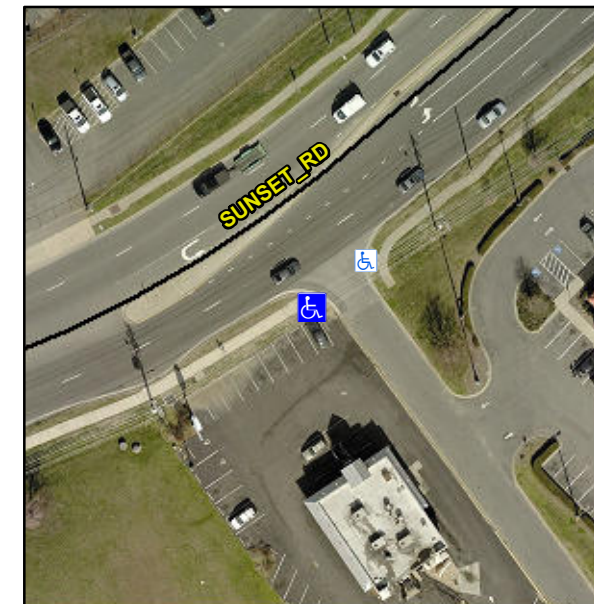
Compliance	Description	Data	Compliance	Description	Data
N/A	Ramp Length (in)	132.0	N/A	Grade Break?	N/A
Yes	Ramp Width (in)	69.0	N/A	Grade Break Slope (%)	0.0
No	Ramp Slope (%)	8.8	N/A	Grade Break XSlope (%)	0.0
Yes	Ramp XSlope (%)	0.1			
N/A	Flare Type LT	N/A	N/A	Flare Type RT	N/A
N/A	Flare Slope LT (%)	N/A	N/A	Flare Slope RT (%)	0.0
N/A	Flare Traversable LT?	N/A	N/A	Flare Traversable RT?	N/A
N/A	Landing Length (in)	0.0	N/A	DWS Provided?	N/A
N/A	Landing Width (in)	0.0	N/A	DWS Contrast?	N/A
N/A	Landing Slope (%)	0.0	N/A	DWS Length (in)	N/A
N/A	Landing X Slope (%)	0.0	N/A	DWS Full Width?	N/A
N/A	Landing Curb? (Y/N)	N/A	N/A	DWS Offset LT (in)	N/A
N/A	Shared Landing?	N/A	N/A	DWS Offset RT (in)	N/A
N/A	Gutter Ponding?	0.0	N/A	Gutter Slope (%)	N/A
N/A	Gutter Lip Ht (in)	0.0	N/A	Gutter X Slope (%)	N/A
N/A	Painted X Walk1?	No		Road Slope (%)	0.9
	X Walk 1 Direction	To NE		Road X Slope (%)	3.8
	X Walk 1 Width (in)	N/A		Clear Space?	N/A

X Walk 1 Slope (%)	0.9	N/A	Clear Space to XWalk (in)	N/A
	X Walk 1 X Slope (%)	3.8	N/A	Storm Grate/Utility Hazard?	N/A
N/A	Ramp inside XWalk1?	N/A		Storm Grate/Utility Type	
N/A	Any Obstructions?	N/A			N/A
	Obstruction Type		Yes	Surface Condition? (G/P)	Good
			N/A	Curb Slope (%)	2.6

Possible Solutions:

**Remove & Replace Entire Ramp.**

PROW/ADA:

**R304.2.2**
