Access Compliance Report

Public Rights-of-Way

(Curb Ramps)

Intersection ID: 13905	Main Street: CENTRAL_AV	Cross Street: SHERIDAN_DR	Location: SE
ADA ID: DC2127D99A99	Ramp Type: Perp	Initial Pass/Fail: Fail	Overall Compliance: No
		Severity Score: 30

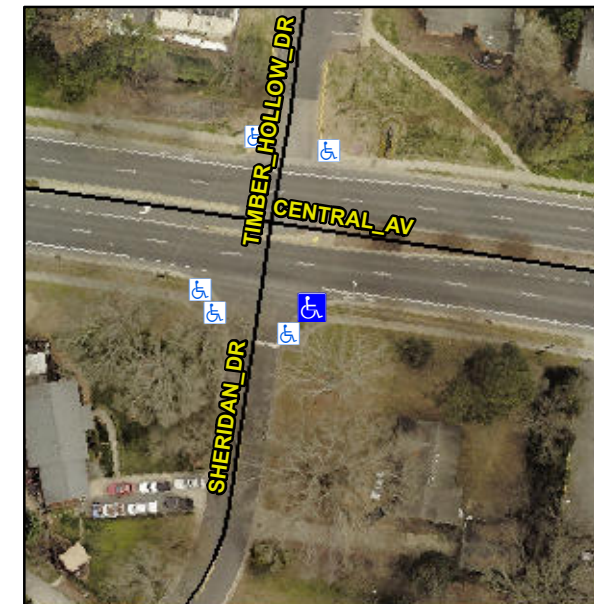
Not Found, R304.5.1, R304.5.3

Compliance	Description	Data	Compliance	Description	Data
N/A	Ramp Length (in)	60.0	Yes	Ramp Slope (%)	5.2
No	Ramp Width (in)	34.5	No	Ramp XSlope (%)	6.4
N/A	Flare Type LT	N/A	N/A	Flare Type RT	N/A
N/A	Flare Slope LT (%)	N/A	N/A	Flare Slope RT (%)	N/A
N/A	Flare Traversable LT?	N/A	N/A	Flare Traversable RT?	N/A
N/A	Landing Length (in)	N/A	N/A	DWS Provided?	N/A
N/A	Landing Width (in)	N/A	N/A	DWS Contrast?	N/A
N/A	Landing Slope (%)	N/A	N/A	DWS Length (in)	N/A
N/A	Landing X Slope (%)	N/A	N/A	DWS Full Width?	N/A
N/A	Landing Curb? (Y/N)	N/A	N/A	DWS Offset (in)	N/A
N/A	Shared Landing?	N/A			
N/A	Gutter Ponding?	N/A	N/A	Gutter Slope (%)	N/A
N/A	Gutter Lip Ht (in)	N/A	N/A	Gutter X Slope (%)	N/A
N/A	Painted X Walk1?	No	N/A	Painted X Walk2?	N/A
	X Walk 1 Direction	To N		X Walk 2 Direction	N/A
N/A	X Walk 1 Width (in)	N/A	N/A	X Walk 2 Width (in)	N/A
	X Walk 1 Slope (%)	7.4		X Walk 2 Slope (%)	N/A
	X Walk 1 X Slope (%)	2.2		X Walk 2 X Slope (%)	N/A

Remove & Replace Entire Ramp.
