Access Compliance Report

Public Rights-of-Way

(Curb Ramps)

Intersection ID: 28367	Main Street: SOUTHAMPTON COMMONS DR	Cross Street: TRAVIS GULCH DR	Location: NW
ADA ID: DC21E56D22D4	Ramp Type: PerpDiag	Initial Pass/Fail: Pass	Overall Compliance: No
Severity Score: 17.75			
Codes/Mitigation Info/Possible Solution		Field Measurements/Component Compliance

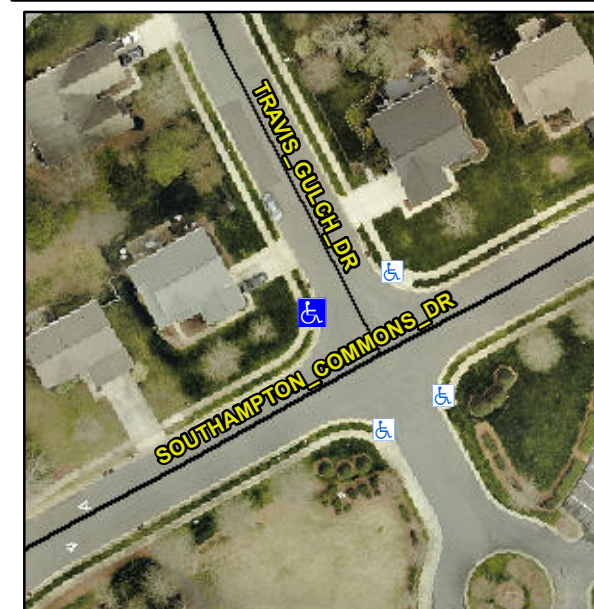
Not Found, R304.5.3, R305, R302.7.2

Compliance	Description	Data	Compliance	Description	Data
N/A	Ramp Length (in)	45.0	Yes	Ramp Slope (%)	7.5
Yes	Ramp Width (in)	48.0	No	Ramp XSlope (%)	3.2
N/A	Flare Type LT	Sloped	N/A	Flare Type RT	N/A
N/A	Flare Slope LT (%)	6.4	Yes	Flare Slope RT (%)	6.6
N/A	Flare Traversable LT?	Yes	N/A	Flare Traversable RT?	Yes
Yes	Landing Length (in)	48.0	No	DWS Provided?	No
Yes	Landing Width (in)	48.0	N/A	DWS Contrast?	No
Yes	Landing Slope (%)	1.9	N/A	DWS Length (in)	N/A
Yes	Landing X Slope (%)	1.0	N/A	DWS Full Width?	No
N/A	Landing Curb? (Y/N)	No	N/A	DWS Offset (in)	N/A
N/A	Shared Landing?	No			
Yes	Gutter Ponding?	No	Yes	Gutter Slope (%)	3.6
No	Gutter Lip Ht (in)	0.5	Yes	Gutter X Slope (%)	1.5
N/A	Painted X Walk1?	No	N/A	Painted X Walk2?	No
	X Walk 1 Direction	To S		X Walk 2 Direction	To E
N/A	X Walk 1 Width (in)	N/A	N/A	X Walk 2 Width (in)	N/A
	X Walk 1 Slope (%)	0.1		X Walk 2 Slope (%)	2.8
	X Walk 1 X Slope (%)	1.6		X Walk 2 X Slope (%)	0.6

N/A	Ramp inside XWalk1?	N/A	N/A	Ramp inside XWalk2?	N/A
	Road Slope (%)	0.3	N/A	Clear Space?	Yes
	Road X Slope (%)	0.2	N/A	Clear Space to XWalk (in)	N/A
Yes	Any Obstructions?	No	Yes	Storm Grate/Utility Hazard?	No
	Obstruction Type			Storm Grate/Utility Type	
		N/A			N/A
		Yes		Surface Condition? (G/P)	Good

Remove & Replace Curb Ramp With Two New Directional Ramps or Equivalent.

Total Cost: \$ 3200.00
