Access Compliance Report

Public Rights-of-Way

(Curb Ramps)

Intersection ID: 18605	Main Street: MOCKINGBIRD_LN	Cross Street: PARK_RD	Location: NE
ADA ID: DC238E469293	Ramp Type: Directional1	Initial Pass/Fail: Fail	Overall Compliance: No
Severity Score: 1.25			
Codes/Mitigation Info/Possible Solution		Field Measurements/Component Compliance

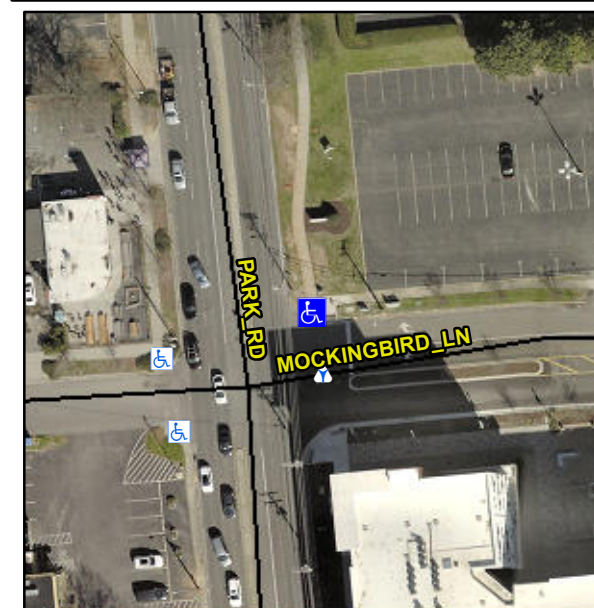
Compliance	Description	Data	Compliance	Description	Data
N/A	Ramp Length (in)	43.0	N/A	Grade Break?	N/A
Yes	Ramp Width (in)	48.0	N/A	Grade Break Slope (%)	0.0
Yes	Ramp Slope (%)	6.0	N/A	Grade Break XSlope (%)	0.0
No	Ramp XSlope (%)	3.0			
N/A	Flare Type LT	N/A	N/A	Flare Type RT	N/A
N/A	Flare Slope LT (%)	N/A	N/A	Flare Slope RT (%)	0.0
N/A	Flare Traversable LT?	N/A	N/A	Flare Traversable RT?	N/A
N/A	Landing Length (in)	0.0	N/A	DWS Provided?	N/A
N/A	Landing Width (in)	0.0	N/A	DWS Contrast?	N/A
N/A	Landing Slope (%)	0.0	N/A	DWS Length (in)	N/A
N/A	Landing X Slope (%)	0.0	N/A	DWS Full Width?	N/A
N/A	Landing Curb? (Y/N)	N/A	N/A	DWS Offset LT (in)	N/A
N/A	Shared Landing?	N/A	N/A	DWS Offset RT (in)	N/A
N/A	Gutter Ponding?	0.0	N/A	Gutter Slope (%)	N/A
N/A	Gutter Lip Ht (in)	0.0	N/A	Gutter X Slope (%)	N/A
N/A	Painted X Walk1?	No		Road Slope (%)	0.7
	X Walk 1 Direction	To SE		Road X Slope (%)	0.9
	X Walk 1 Width (in)	N/A		Clear Space?	N/A

X Walk 1 Slope (%)	0.7	N/A	Clear Space to XWalk (in)	N/A
	X Walk 1 X Slope (%)	0.9	N/A	Storm Grate/Utility Hazard?	N/A
N/A	Ramp inside XWalk1?	N/A		Storm Grate/Utility Type	
N/A	Any Obstructions?	N/A			N/A
	Obstruction Type		Yes	Surface Condition? (G/P)	Good
			N/A	Curb Slope (%)	26.0

Possible Solutions:

Remove & Replace Entire Ramp.
