## Access Compliance Report Public Rights-of-Way (Curb Ramps)

Intersection ID: 21445 Main Street: CHAMPAIGN\_ST Cross Street: COTILLION\_AV Location: N

ADA ID: DC28C1478D56 Ramp Type: PerpDiag Initial Pass/Fail: Fail Overall Compliance: No Severity Score: 37.5

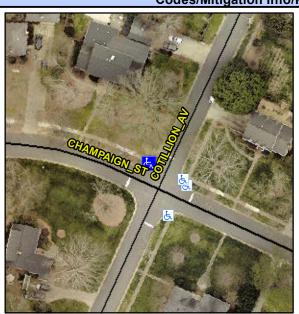
Not Found, R304.2.2, R304.5.3

ried Measurements/Component Compliance						
Compliance Description		Data	a Compliance Description		Data	
N/A	Ramp Length (in)	33.5	No	Ramp Slope (%)	11.4	
Yes	Ramp Width (in)	68.0	No	Ramp XSlope (%)	8.1	
N/A	Flare Type LT	N/A	N/A	Flare Type RT	N/A	
N/A	Flare Slope LT (%)	N/A	N/A	Flare Slope RT (%)	N/A	
N/A	Flare Traversable LT?	N/A	N/A	Flare Traversable RT?	N/A	
N/A	Landing Length (in)	N/A	N/A	DWS Provided?	N/A	
N/A	Landing Width (in)	N/A	N/A	DWS Contrast?	N/A	
N/A	Landing Slope (%)	N/A	N/A	DWS Length (in)	N/A	
N/A	Landing X Slope (%)	N/A	N/A	DWS Full Width?	N/A	
N/A	Landing Curb? (Y/N)	N/A	N/A	DWS Offset (in)	N/A	
N/A	Shared Landing?	N/A				
N/A	Gutter Ponding?	N/A	N/A	Gutter Slope (%)	N/A	
N/A	Gutter Lip Ht (in)	N/A	N/A	Gutter X Slope (%)	N/A	
N/A	Painted X Walk1?	No	N/A	Painted X Walk2?	No	
	X Walk 1 Direction	To SW		X Walk 2 Direction	To SE	
N/A	X Walk 1 Width (in)	N/A	N/A	X Walk 2 Width (in)	N/A	
	X Walk 1 Slope (%)	8.0		X Walk 2 Slope (%)	2.1

X Walk 1 X Slope (%)	0.3		X Walk 2 X Slope (%)	7.9	
N/A	Ramp inside XWalk1?	N/A	N/A	Ramp inside XWalk2?	N/A	
	Road Slope (%)	8.0	N/A	Clear Space?	N/A	
	Road X Slope (%)	10.2	N/A	Clear Space to XWalk (in)	N/A	
N/A	Any Obstructions?	N/A	N/A	Storm Grate/Utility Hazard?	N/A

Remove & Replace Curb Ramp With Two New Directional Ramps or Equivalent.
