Access Compliance Report

Public Rights-of-Way

(Curb Ramps)

| Intersection ID: 2805 | Main Street: GLEN_MANOR_DR | Cross Street: GLEN_ROYAL_DR | Location: NE |

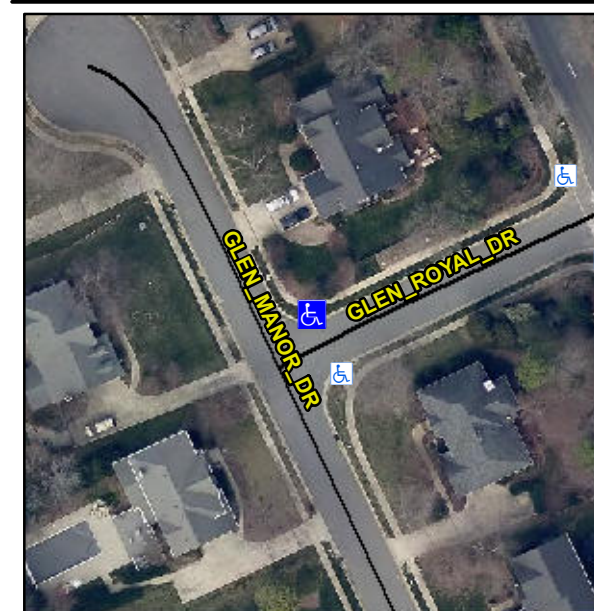
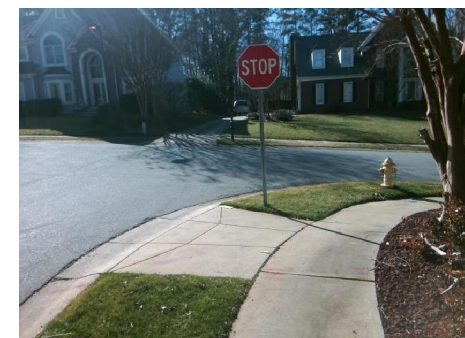
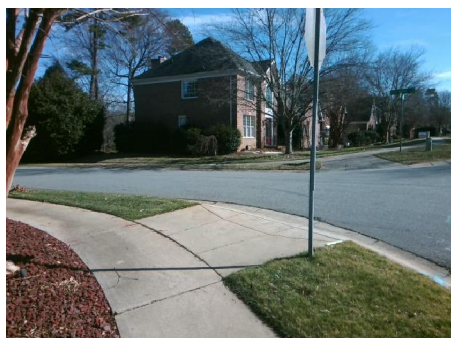
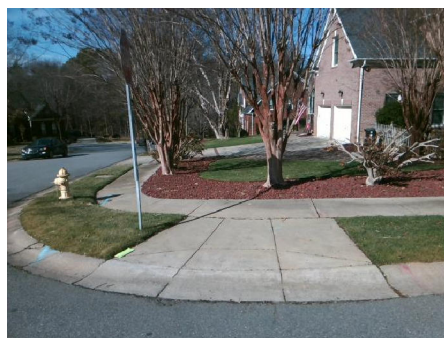
| ADA ID: DC441CC2ECCA | Ramp Type: BlendTrans1 | Initial Pass/Fail: Fail | Overall Compliance: No |

Not Found, R304.5.1, R304.5.3

| Compliance | Description | Data | Compliance | Description | Data |
|---|---|---|---|---|---|
| No | Ramp Width (in) | 32.0 | No | BlendTrans XSlope (%) | 6.3 |
| | | | No | Curb Slope (%) | 6.5 |

Remove & Replace Curb Ramp With Two New Directional Ramps or Equivalent.
