# Access Compliance Report

## Public Rights-of-Way

### (Curb Ramps)

Intersection ID: 9046	Main Street: BRADFORD_DR	Cross Street: HOOVER_ST	Location: NE
ADA ID: DC4814821308	Ramp Type: Perp	Initial Pass/Fail: Fail	Overall Compliance: No
Severity Score: 25			
Codes/Mitigation Info/Possible Solution		Field Measurements/Component Compliance

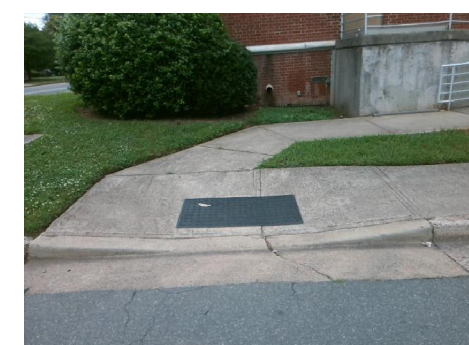
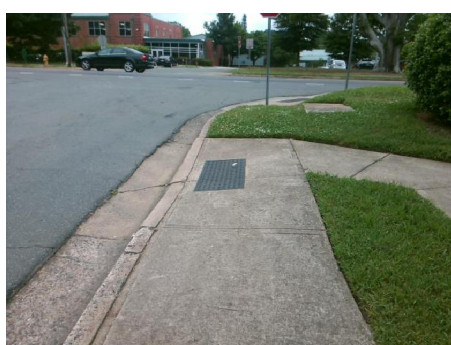
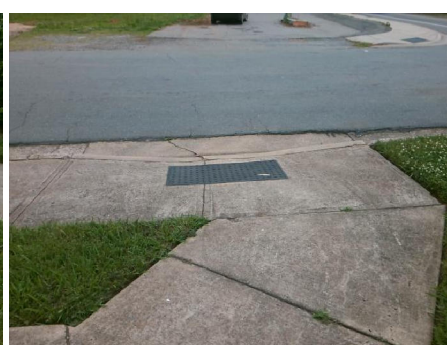
**Not Found, R304.2.2, R304.5.3**

Compliance	Description	Data	Compliance	Description	Data
N/A	Ramp Length (in)	60.0	No	Ramp Slope (%)	11.4
Yes	Ramp Width (in)	48.0	No	Ramp XSlope (%)	5.8
N/A	Flare Type LT	N/A	N/A	Flare Type RT	N/A
N/A	Flare Slope LT (%)	N/A	N/A	Flare Slope RT (%)	N/A
N/A	Flare Traversable LT?	N/A	N/A	Flare Traversable RT?	N/A
N/A	Landing Length (in)	N/A	N/A	DWS Provided?	N/A
N/A	Landing Width (in)	N/A	N/A	DWS Contrast?	N/A
N/A	Landing Slope (%)	N/A	N/A	DWS Length (in)	N/A
N/A	Landing X Slope (%)	N/A	N/A	DWS Full Width?	N/A
N/A	Landing Curb? (Y/N)	N/A	N/A	DWS Offset (in)	N/A
N/A	Shared Landing?	N/A			
N/A	Gutter Ponding?	N/A	N/A	Gutter Slope (%)	N/A
N/A	Gutter Lip Ht (in)	N/A	N/A	Gutter X Slope (%)	N/A
N/A	Painted X Walk1?	No	N/A	Painted X Walk2?	N/A
	X Walk 1 Direction	To S		X Walk 2 Direction	N/A
N/A	X Walk 1 Width (in)	N/A	N/A	X Walk 2 Width (in)	N/A
	X Walk 1 Slope (%)	3.5		X Walk 2 Slope (%)	N/A
	X Walk 1 X Slope (%)	6.1		X Walk 2 X Slope (%)	N/A

N/A	Ramp inside XWalk1?	N/A	N/A	Ramp inside XWalk2?	N/A
	Road Slope (%)	N/A	N/A	Clear Space?	N/A
	Road X Slope (%)	N/A	N/A	Clear Space to XWalk (in)	N/A
N/A	Any Obstructions?	N/A	N/A	Storm Grate/Utility Hazard?	N/A
	Obstruction Type			Storm Grate/Utility Type	
		N/A			N/A
			Yes	Surface Condition? (G/P)	Good

**Remove & Replace Entire Ramp.**
