Access Compliance Report

Public Rights-of-Way

(Curb Ramps)

Intersection ID: 3352	Main Street: DAVIS_RIDGE_DR	Cross Street: FALLS_RIDGE_LN	Location: SW
ADA ID: DC4AD2E98E9B	Ramp Type: PerpDiag	Initial Pass/Fail: Fail	Overall Compliance: No
Severity Score: 33.75			
Codes/Mitigation Info/Possible Solution		Field Measurements/Component Compliance

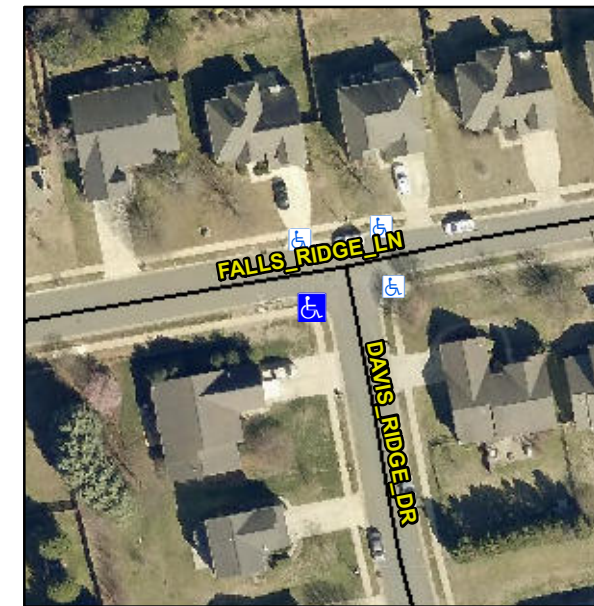
Compliance	Description	Data	Compliance	Description	Data
N/A	Ramp Length (in)	48.0	Yes	Ramp Slope (%)	5.6
No	Ramp Width (in)	47.0	No	Ramp XSlope (%)	11.9
N/A	Flare Type LT	N/A	N/A	Flare Type RT	N/A
N/A	Flare Slope LT (%)	N/A	N/A	Flare Slope RT (%)	N/A
N/A	Flare Traversable LT?	N/A	N/A	Flare Traversable RT?	N/A
N/A	Landing Length (in)	N/A	N/A	DWS Provided?	N/A
N/A	Landing Width (in)	N/A	N/A	DWS Contrast?	N/A
N/A	Landing Slope (%)	N/A	N/A	DWS Length (in)	N/A
N/A	Landing X Slope (%)	N/A	N/A	DWS Full Width?	N/A
N/A	Landing Curb? (Y/N)	N/A	N/A	DWS Offset (in)	N/A
N/A	Shared Landing?	N/A			
N/A	Gutter Ponding?	N/A	N/A	Gutter Slope (%)	N/A
N/A	Gutter Lip Ht (in)	N/A	N/A	Gutter X Slope (%)	N/A
N/A	Painted X Walk1?	No	N/A	Painted X Walk2?	No
	X Walk 1 Direction	To E		X Walk 2 Direction	To N
N/A	X Walk 1 Width (in)	N/A	N/A	X Walk 2 Width (in)	N/A
	X Walk 1 Slope (%)	4.1		X Walk 2 Slope (%)	5.5
	X Walk 1 X Slope (%)	10.6		X Walk 2 X Slope (%)	6.8

N/A	Ramp inside XWalk1?	N/A	N/A	Ramp inside XWalk2?	N/A
	Road Slope (%)	11.0	N/A	Clear Space?	N/A
	Road X Slope (%)	2.5	N/A	Clear Space to XWalk (in)	N/A
N/A	Any Obstructions?	N/A	N/A	Storm Grate/Utility Hazard?	N/A
	Obstruction Type			Storm Grate/Utility Type	
		N/A			N/A
		Yes		Surface Condition? (G/P)	Good

Remove & Replace Curb Ramp With Two New Directional Ramps or Equivalent.

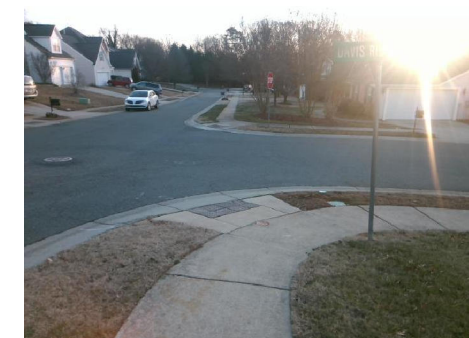
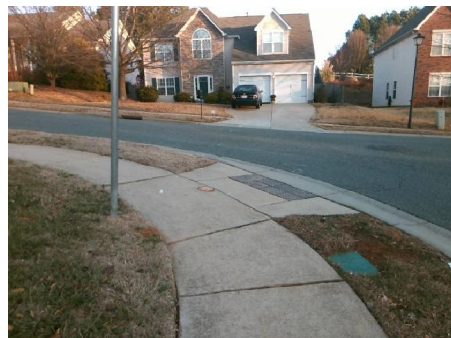
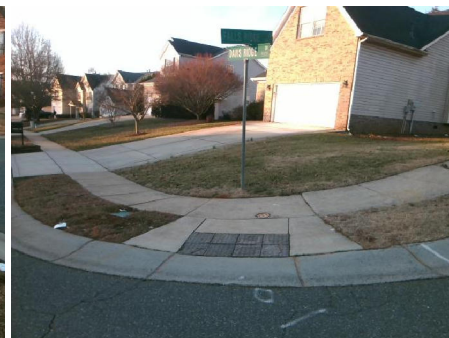
Street 1 Name DAVIS RIDGE DR
 Stop Condition-Street 2 StopSign
 Street 2 Name FALLS RIDGE LN
 Stop Condition-Street 1 None
