Access Compliance Report

Public Rights-of-Way

(Curb Ramps)

Intersection ID: 24499	Main Street: BECKMORE_PL	Cross Street: SAINTFIELD_PL	Location: SW
ADA ID: DC52E0F2BF33	Ramp Type: Perp	Initial Pass/Fail: Pass	Overall Compliance: No
Severity Score: 5			
Codes/Mitigation Info/Possible Solution		Field Measurements/Component Compliance

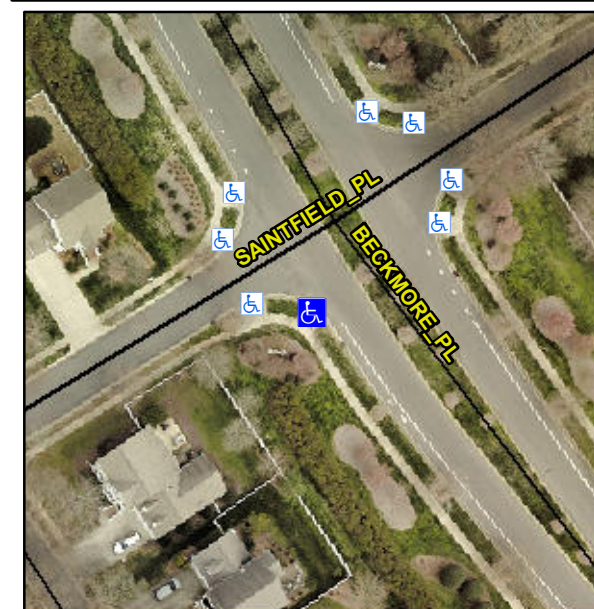
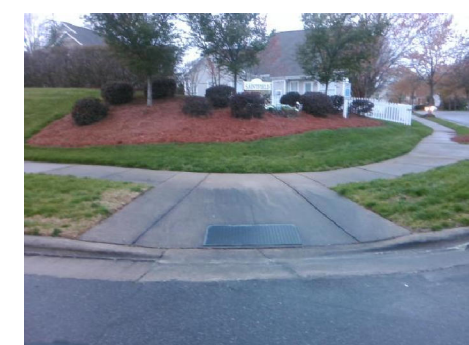
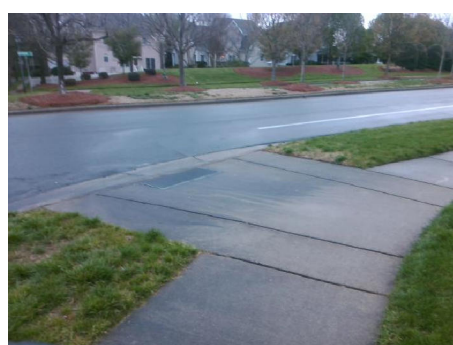
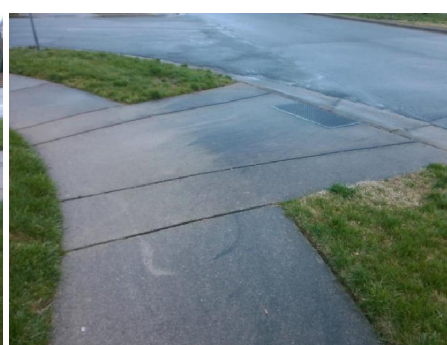
Compliance	Description	Data	Compliance	Description	Data
N/A	Ramp Length (in)	96.0	Yes	Ramp Slope (%)	8.0
Yes	Ramp Width (in)	48.0	Yes	Ramp XSlope (%)	1.1
N/A	Flare Type LT	Sloped	N/A	Flare Type RT	N/A
N/A	Flare Slope LT (%)	10.1	Yes	Flare Slope RT (%)	6.3
N/A	Flare Traversable LT?	Yes	N/A	Flare Traversable RT?	Yes
Yes	Landing Length (in)	62.0	Yes	DWS Provided?	Yes
Yes	Landing Width (in)	48.0	Yes	DWS Contrast?	Yes
No	Landing Slope (%)	4.4	Yes	DWS Length (in)	24.5
No	Landing X Slope (%)	3.9	No	DWS Full Width?	No
N/A	Landing Curb? (Y/N)	No	Yes	DWS Offset (in)	2.0
N/A	Shared Landing?	No			
Yes	Gutter Ponding?	No	Yes	Gutter Slope (%)	2.1
Yes	Gutter Lip Ht (in)	0.0	Yes	Gutter X Slope (%)	2.5
N/A	Painted X Walk1?	No	N/A	Painted X Walk2?	N/A
	X Walk 1 Direction	To E		X Walk 2 Direction	N/A
N/A	X Walk 1 Width (in)	N/A	N/A	X Walk 2 Width (in)	N/A
	X Walk 1 Slope (%)	6.7		X Walk 2 Slope (%)	N/A
	X Walk 1 X Slope (%)	3.0		X Walk 2 X Slope (%)	N/A

N/A	Ramp inside XWalk1?	N/A	N/A	Ramp inside XWalk2?	N/A
	Road Slope (%)	N/A	N/A	Clear Space?	Yes
	Road X Slope (%)	N/A	N/A	Clear Space to XWalk (in)	N/A
Yes	Any Obstructions?	No	Yes	Storm Grate/Utility Hazard?	No
	Obstruction Type			Storm Grate/Utility Type	
		N/A			N/A
			Yes	Surface Condition? (G/P)	Good

Remove & Replace Entire Ramp.
