Access Compliance Report

Public Rights-of-Way

(Curb Ramps)

Intersection ID: N/A	Main Street: PINEVILLE-MATTHEWS_RD	Cross Street: CHALLIS_FARM_RD	Location: SE
ADA ID: DC671D69CB36	Ramp Type: PerpDiag	Initial Pass/Fail: Fail	Overall Compliance: No
Severity Score: 22.5			
Codes/Mitigation Info/Possible Solution		Field Measurements/Component Compliance

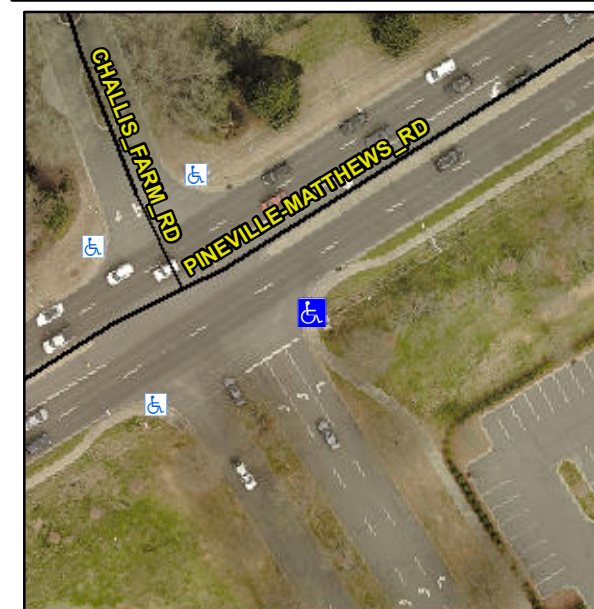
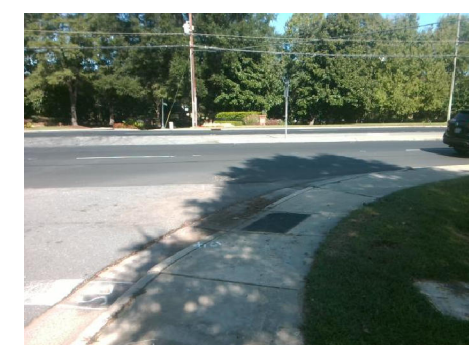
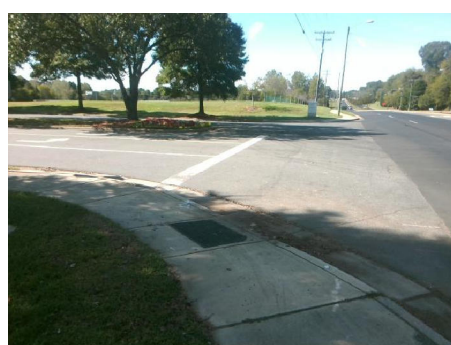
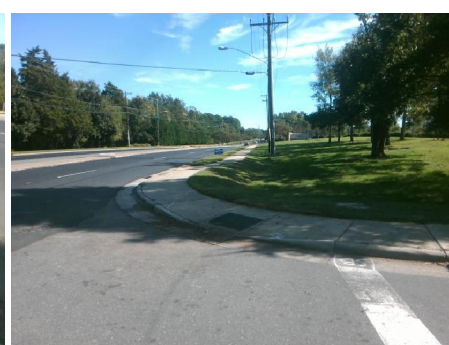
Not Found, R304.5.1, R304.2.2, R304.5.3

Compliance	Description	Data	Compliance	Description	Data
N/A	Ramp Length (in)	60.0	No	Ramp Slope (%)	10.2
No	Ramp Width (in)	42.0	No	Ramp XSlope (%)	2.4
N/A	Flare Type LT	N/A	N/A	Flare Type RT	N/A
N/A	Flare Slope LT (%)	N/A	N/A	Flare Slope RT (%)	N/A
N/A	Flare Traversable LT?	N/A	N/A	Flare Traversable RT?	N/A
N/A	Landing Length (in)	N/A	N/A	DWS Provided?	N/A
N/A	Landing Width (in)	N/A	N/A	DWS Contrast?	N/A
N/A	Landing Slope (%)	N/A	N/A	DWS Length (in)	N/A
N/A	Landing X Slope (%)	N/A	N/A	DWS Full Width?	N/A
N/A	Landing Curb? (Y/N)	N/A	N/A	DWS Offset (in)	N/A
N/A	Shared Landing?	N/A			
N/A	Gutter Ponding?	N/A	N/A	Gutter Slope (%)	N/A
N/A	Gutter Lip Ht (in)	N/A	N/A	Gutter X Slope (%)	N/A
N/A	Painted X Walk1?	No	N/A	Painted X Walk2?	No
	X Walk 1 Direction	To N		X Walk 2 Direction	To SW
N/A	X Walk 1 Width (in)	N/A	N/A	X Walk 2 Width (in)	N/A
	X Walk 1 Slope (%)	1.1		X Walk 2 Slope (%)	0.8
	X Walk 1 X Slope (%)	1.8		X Walk 2 X Slope (%)	0.3

N/A	Ramp inside XWalk1?	N/A	N/A	Ramp inside XWalk2?	N/A
	Road Slope (%)	0.2	N/A	Clear Space?	N/A
	Road X Slope (%)	0.2	N/A	Clear Space to XWalk (in)	N/A
N/A	Any Obstructions?	N/A	N/A	Storm Grate/Utility Hazard?	N/A
	Obstruction Type			Storm Grate/Utility Type	
		N/A			N/A
			Yes	Surface Condition? (G/P)	Good

Remove & Replace Curb Ramp With Two New Directional Ramps or Equivalent.
