Access Compliance Report

Public Rights-of-Way

(Curb Ramps)

Intersection ID: 21216	Main Street: BROOKDALE_AV	Cross Street: WOODSTREAM_DR	Location: SE
ADA ID: DC693A0750E5	Ramp Type: Perp	Initial Pass/Fail: Fail	Overall Compliance: No
		Severity Score: 1.25

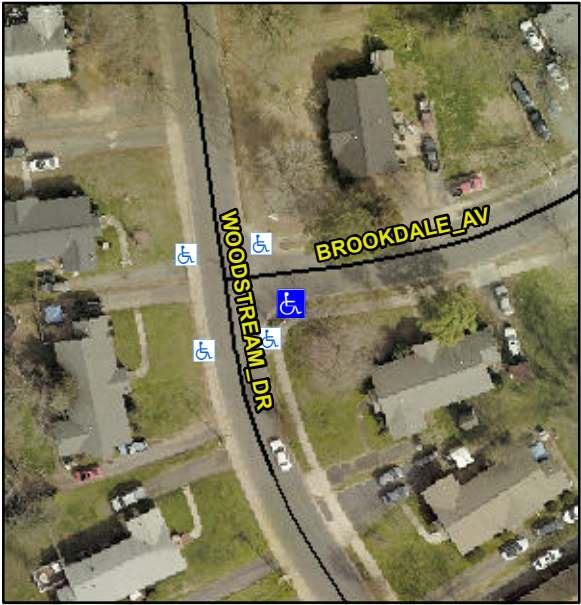
Possible Solutions:		Compliance	Description	Data
	Remove & Replace Entire Ramp.		Yes	Ramp Length (in)	52.0
			No	Ramp Width (in)	48.0
			N/A	Flare Type LT	N/A
			N/A	Flare Slope LT (%)	N/A
			N/A	Flare Traversable LT?	N/A
			N/A	Landing Length (in)	N/A
			N/A	Landing Width (in)	N/A
			N/A	Landing Slope (%)	N/A
			N/A	Landing X Slope (%)	N/A
			N/A	Landing Curb? (Y/N)	N/A
			N/A	Shared Landing?	N/A
			N/A	Gutter Ponding?	N/A
			N/A	Gutter Lip Ht (in)	N/A
			No	Painted X Walk1?	N/A
			To N	X Walk 1 Direction	N/A
			N/A	X Walk 1 Width (in)	N/A

4.2	X Walk 1 Slope (%)	N/A
			0.7	X Walk 1 X Slope (%)	N/A
			N/A	Ramp inside XWalk1?	N/A
<p>Surveyor Notes:</p> <p>N/A</p> <p>PROW/ADA:</p> <p>Not Found, R304.5.3</p>			N/A	Flare Type RT	N/A
			N/A	Flare Slope RT (%)	N/A
			N/A	Flare Traversable RT?	N/A
			N/A	DWS Provided?	N/A
			N/A	DWS Contrast?	N/A
			N/A	DWS Length (in)	N/A
			N/A	DWS Full Width?	N/A
			N/A	DWS Offset (in)	N/A
			N/A	Gutter Slope (%)	N/A
			N/A	Gutter X Slope (%)	N/A
			N/A	Painted X Walk2?	N/A
			N/A	X Walk 2 Direction	N/A
			N/A	X Walk 2 Width (in)	N/A
			N/A	X Walk 2 Slope (%)	N/A
			N/A	X Walk 2 X Slope (%)	N/A
			N/A	Ramp inside XWalk2?	N/A
			N/A	Clear Space?	N/A
			N/A	Clear Space to XWalk (in)	N/A
			N/A	Storm Grate/Utility Hazard?	N/A
			N/A	Storm Grate/Utility Type	N/A
			N/A	Surface Condition? (G/P)	Good
Total Cost:		\$ 1850.00
