Access Compliance Report

Public Rights-of-Way

(Curb Ramps)

Intersection ID: 18701	Main Street: PROVIDENCE_RD	Cross Street: RUTLEDGE_AV	Location: SE
ADA ID: DC6E749405E0	Ramp Type: PerpDiag	Initial Pass/Fail: Fail	Overall Compliance: No
Codes/Mitigation Info/Possible Solution		Field Measurements/Component Compliance	
Severity Score: 22.5

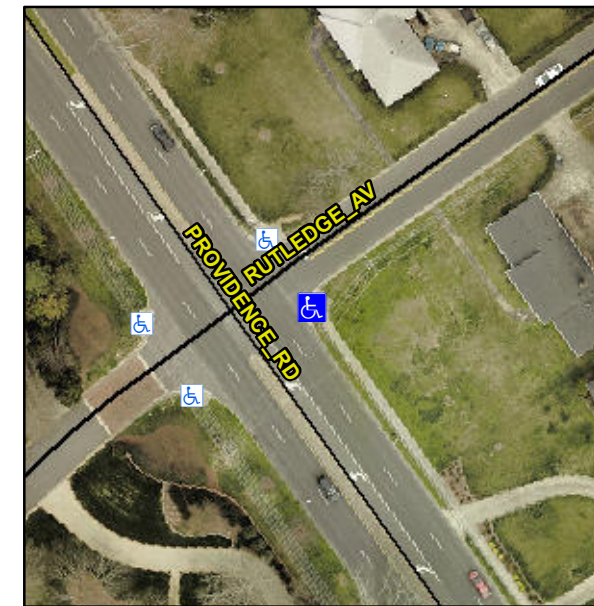
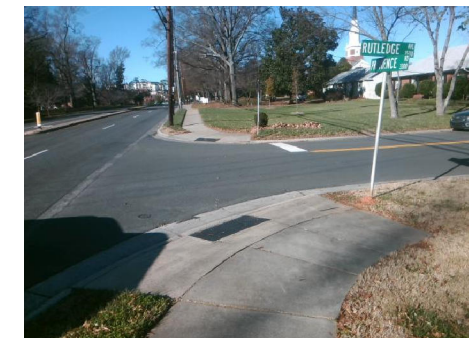
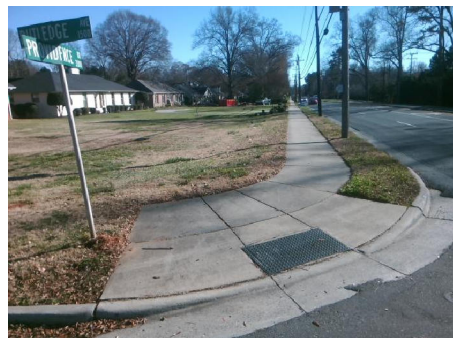
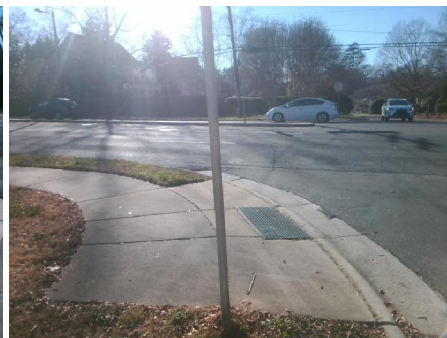
Not Found, R304.5.1, R304.2.2, R304.5.3

Compliance	Description	Data	Compliance	Description	Data
N/A	Ramp Length (in)	48.0	No	Ramp Slope (%)	9.0
No	Ramp Width (in)	38.0	No	Ramp XSlope (%)	3.1
N/A	Flare Type LT	N/A	N/A	Flare Type RT	N/A
N/A	Flare Slope LT (%)	N/A	N/A	Flare Slope RT (%)	N/A
N/A	Flare Traversable LT?	N/A	N/A	Flare Traversable RT?	N/A
N/A	Landing Length (in)	N/A	N/A	DWS Provided?	N/A
N/A	Landing Width (in)	N/A	N/A	DWS Contrast?	N/A
N/A	Landing Slope (%)	N/A	N/A	DWS Length (in)	N/A
N/A	Landing X Slope (%)	N/A	N/A	DWS Full Width?	N/A
N/A	Landing Curb? (Y/N)	N/A	N/A	DWS Offset (in)	N/A
N/A	Shared Landing?	N/A			
N/A	Gutter Ponding?	N/A	N/A	Gutter Slope (%)	N/A
N/A	Gutter Lip Ht (in)	N/A	N/A	Gutter X Slope (%)	N/A
N/A	Painted X Walk1?	No	N/A	Painted X Walk2?	No
	X Walk 1 Direction	To NW		X Walk 2 Direction	To SW
N/A	X Walk 1 Width (in)	N/A	N/A	X Walk 2 Width (in)	N/A
	X Walk 1 Slope (%)	6.7		X Walk 2 Slope (%)	9.5
	X Walk 1 X Slope (%)	6.3		X Walk 2 X Slope (%)	5.0

N/A	Ramp inside XWalk1?	N/A	N/A	Ramp inside XWalk2?	N/A
	Road Slope (%)	4.5	N/A	Clear Space?	N/A
	Road X Slope (%)	8.8	N/A	Clear Space to XWalk (in)	N/A
N/A	Any Obstructions?	N/A	N/A	Storm Grate/Utility Hazard?	N/A
	Obstruction Type			Storm Grate/Utility Type	
		N/A			N/A
			Yes	Surface Condition? (G/P)	Good

Remove & Replace Curb Ramp With Two New Directional Ramps or Equivalent.
