# Access Compliance Report

## Public Rights-of-Way

| Intersection ID: 30277 | Main Street: EMDEN_CT | Cross Street: RAVANNA_DR | Location: NE |
| ADA ID: DC722A1C0BC3 | Ramp Type: BlendTrans1 | Initial Pass/Fail: Pass | Overall Compliance: No |

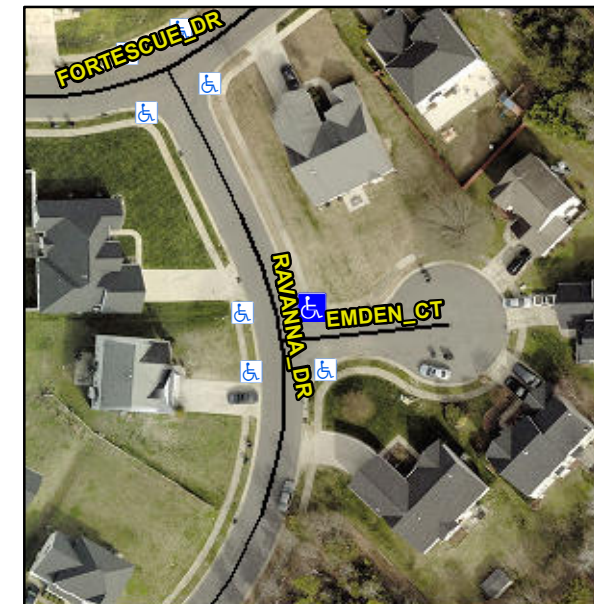
**CURB WIDTH 31.0, ASP LIP PREVENTED GTR SLOPE**

**Not Found, R304.5.3, R304.2.1, R305.2, R304.5.4**

| Compliance | Description | Data | Compliance | Description | Data |
|---|---|---|---|---|---|
| Yes | Ramp Width (in) | 48.0 | No | BlendTrans XSlope (%) | 3.8 |
| No | Landing Length (in) | 47.5 | Yes | DWS Provided? | Yes |
| N/A | Landing Curb? (Y/N) | No | No | DWS Offset (in) | 2.8 |
| Yes | Gutter Lip Ht (in) | 0.0 | No | Gutter X Slope (%) | 3.0 |

**Remove & Replace Curb Ramp With Two New Directional Ramps or Equivalent. Remove & Replace Gutter.**

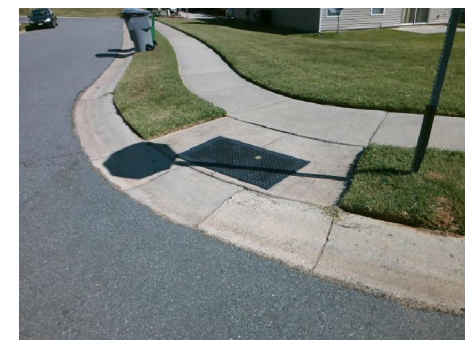
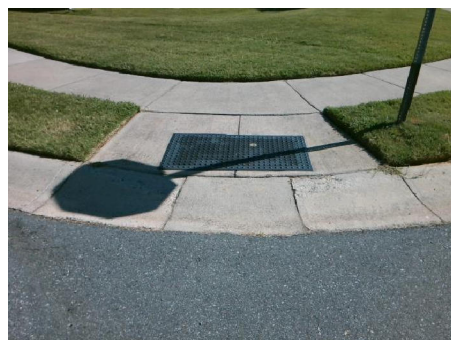
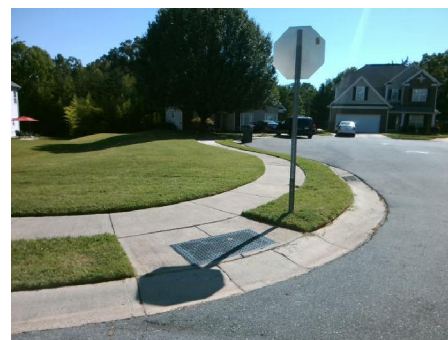
Street 1 Name RAVANNA DR  
 Stop Condition-Street 1 None  
 Street 2 Name EMDEN CT  
 Stop Condition-Street 2 StopSign
