Access Compliance Report

Public Rights-of-Way

(Curb Ramps)

Intersection ID: 16267	Main Street: BEAM_RD	Cross Street: YORKMONT_RD	Location: S
ADA ID: DC7681CE8192	Ramp Type: Perp	Initial Pass/Fail: Fail	Overall Compliance: No
		Severity Score: 25

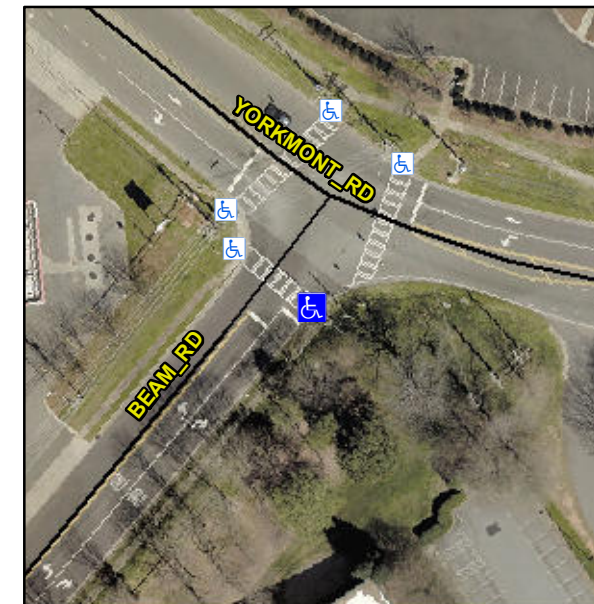
Not Found, R304.2.2

Compliance	Description	Data	Compliance	Description	Data
N/A	Ramp Length (in)	77.0	No	Ramp Slope (%)	12.6
Yes	Ramp Width (in)	50.0	Yes	Ramp XSlope (%)	1.0
N/A	Flare Type LT	N/A	N/A	Flare Type RT	N/A
N/A	Flare Slope LT (%)	N/A	N/A	Flare Slope RT (%)	N/A
N/A	Flare Traversable LT?	N/A	N/A	Flare Traversable RT?	N/A
N/A	Landing Length (in)	N/A	N/A	DWS Provided?	N/A
N/A	Landing Width (in)	N/A	N/A	DWS Contrast?	N/A
N/A	Landing Slope (%)	N/A	N/A	DWS Length (in)	N/A
N/A	Landing X Slope (%)	N/A	N/A	DWS Full Width?	N/A
N/A	Landing Curb? (Y/N)	N/A	N/A	DWS Offset (in)	N/A
N/A	Shared Landing?	N/A			
N/A	Gutter Ponding?	N/A	N/A	Gutter Slope (%)	N/A
N/A	Gutter Lip Ht (in)	N/A	N/A	Gutter X Slope (%)	N/A
N/A	Painted X Walk1?	Yes	N/A	Painted X Walk2?	N/A
	X Walk 1 Direction	To NW		X Walk 2 Direction	N/A
N/A	X Walk 1 Width (in)	111.0	N/A	X Walk 2 Width (in)	N/A
	X Walk 1 Slope (%)	5.8		X Walk 2 Slope (%)	N/A
	X Walk 1 X Slope (%)	1.8		X Walk 2 X Slope (%)	N/A

Remove & Replace Entire Ramp.
