Access Compliance Report

Public Rights-of-Way

(Curb Ramps)

Intersection ID: 43251	Main Street: PARK_RD	Cross Street: PARK_SOUTH_DR	Location: NE
ADA ID: DC7809572A74	Ramp Type: Perp	Initial Pass/Fail: Fail	Overall Compliance: No
		Severity Score: 12.5

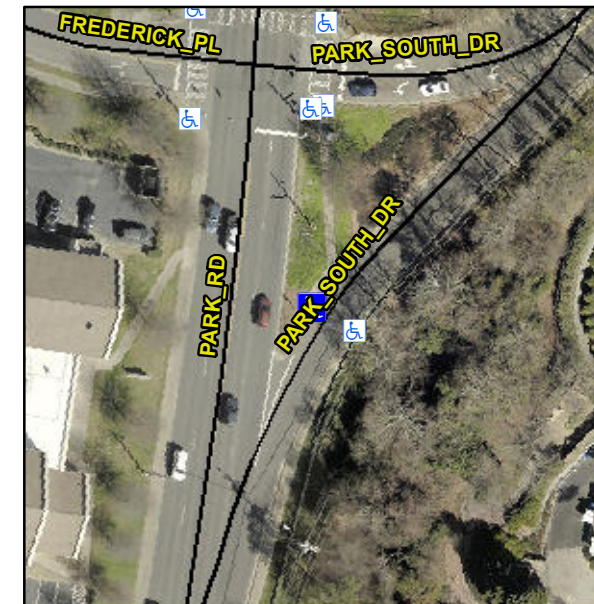
Not Found, R304.2.2

Compliance	Description	Data	Compliance	Description	Data
N/A	Ramp Length (in)	61.0	No	Ramp Slope (%)	10.3
Yes	Ramp Width (in)	48.0	Yes	Ramp XSlope (%)	0.5
N/A	Flare Type LT	N/A	N/A	Flare Type RT	N/A
N/A	Flare Slope LT (%)	N/A	N/A	Flare Slope RT (%)	N/A
N/A	Flare Traversable LT?	N/A	N/A	Flare Traversable RT?	N/A
N/A	Landing Length (in)	N/A	N/A	DWS Provided?	N/A
N/A	Landing Width (in)	N/A	N/A	DWS Contrast?	N/A
N/A	Landing Slope (%)	N/A	N/A	DWS Length (in)	N/A
N/A	Landing X Slope (%)	N/A	N/A	DWS Full Width?	N/A
N/A	Landing Curb? (Y/N)	N/A	N/A	DWS Offset (in)	N/A
N/A	Shared Landing?	N/A			
N/A	Gutter Ponding?	N/A	N/A	Gutter Slope (%)	N/A
N/A	Gutter Lip Ht (in)	N/A	N/A	Gutter X Slope (%)	N/A
N/A	Painted X Walk1?	No	N/A	Painted X Walk2?	N/A
	X Walk 1 Direction	To SE		X Walk 2 Direction	N/A
N/A	X Walk 1 Width (in)	N/A	N/A	X Walk 2 Width (in)	N/A
	X Walk 1 Slope (%)	3.9		X Walk 2 Slope (%)	N/A
	X Walk 1 X Slope (%)	0.8		X Walk 2 X Slope (%)	N/A

N/A	Ramp inside XWalk1?	N/A	N/A	Ramp inside XWalk2?	N/A
	Road Slope (%)	N/A	N/A	Clear Space?	N/A
	Road X Slope (%)	N/A	N/A	Clear Space to XWalk (in)	N/A
N/A	Any Obstructions?	N/A	N/A	Storm Grate/Utility Hazard?	N/A
	Obstruction Type			Storm Grate/Utility Type	
		N/A			N/A
			Yes	Surface Condition? (G/P)	Good

Remove & Replace Entire Ramp.

Total Cost: \$ 1850.00
