Access Compliance Report

Public Rights-of-Way

(Curb Ramps)

Intersection ID: 10033949	Main Street: PARK_RD	Cross Street: N/A	Location: NE
ADA ID: DC7C13C6A957	Ramp Type: BlendTrans2	Initial Pass/Fail: Fail	Overall Compliance: No
		Severity Score: 1.25

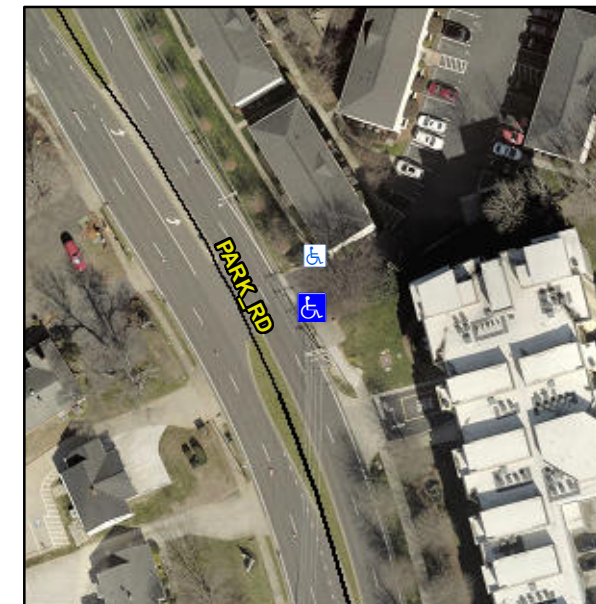
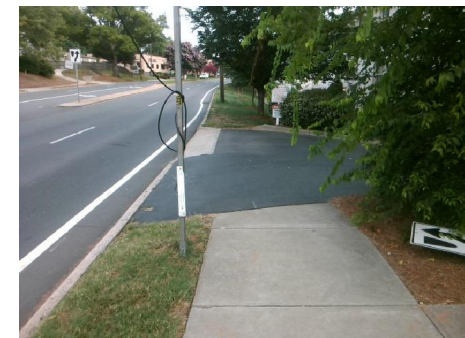
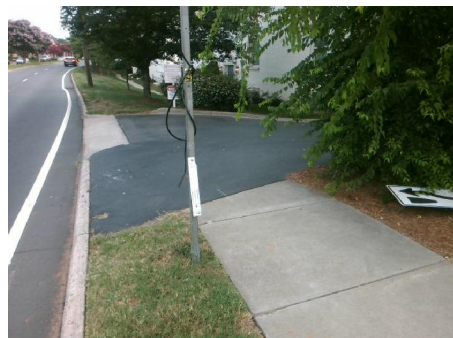
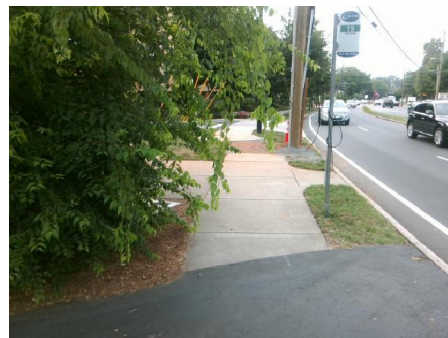
Compliance	Description	Data	Compliance	Description	Data
N/A	Ramp Length (in)	81.0	Yes	BlendTrans Slope (%)	0.5
Yes	Ramp Width (in)	72.0	No	BlendTrans XSlope (%)	3.7
N/A	Flare Type LT	N/A	N/A	Flare Type RT	N/A
N/A	Flare Slope LT (%)	N/A	N/A	Flare Slope RT (%)	N/A
N/A	Flare Traversable LT?	N/A	N/A	Flare Traversable RT?	N/A
N/A	Landing Length (in)	N/A	N/A	DWS Provided?	N/A
N/A	Landing Width (in)	N/A	N/A	DWS Contrast?	N/A
N/A	Landing Slope (%)	N/A	N/A	DWS Length (in)	N/A
N/A	Landing X Slope (%)	N/A	N/A	DWS Full Width?	N/A
N/A	Landing Curb? (Y/N)	N/A	N/A	DWS Offset (in)	N/A
N/A	Shared Landing?	N/A			
N/A	Gutter Ponding?	N/A	N/A	Gutter Slope (%)	N/A
N/A	Gutter Lip Ht (in)	N/A	N/A	Gutter X Slope (%)	N/A
N/A	Painted X Walk1?	No	N/A	Painted X Walk2?	N/A
	X Walk 1 Direction	To NE		X Walk 2 Direction	N/A
	X Walk 1 Width (in)	N/A		X Walk 2 Width (in)	N/A
	X Walk 1 Slope (%)	3.8		X Walk 2 Slope (%)	N/A
	X Walk 1 X Slope (%)	1.7		X Walk 2 X Slope (%)	N/A

N/A	Ramp inside XWalk1?	N/A	N/A	Ramp inside XWalk2?	N/A
	Road Slope (%)	1.7		Clear Space?	N/A
	Road X Slope (%)	3.8	N/A	Clear Space to XWalk (in)	N/A
N/A	Any Obstructions?	N/A	N/A	Storm Grate/Utility Hazard?	N/A
	Obstruction Type			Storm Grate/Utility Type	
		N/A			N/A
			Yes	Surface Condition? (G/P)	Good
			N/A	Curb Slope (%)	N/A

Remove & Replace Curb Ramp With Two New Directional Ramps or Equivalent.

R304.5.3

Total Cost: \$ 3200.00
