## **Access Compliance Report Public Rights-of-Way** (Curb Ramps)

Intersection ID: N/A Main Street: MILLENNIUM\_AV Cross Street: POTOMAC\_RIVER\_PY Location: SE **Overall Compliance: No** ADA ID: DC7F465C5843 Ramp Type: Directional1 Initial Pass/Fail: Fail **Severity Score:** 1.25

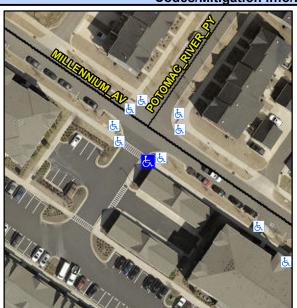
| Possible Solutions: |
|---|
| R304.5.3 |

| K304.3.3 | | | |

| Field Measurements/Component Compliance | | | | | | | | | |
|---|---|---|---|---|---|---|---|--|--|
| No | Ramp XSI | ope (%) | 2.6 | | | | | | |

| Possible Solutions: |
|---|
| Remove & Replace Entire Ramp. |
