Access Compliance Report

Public Rights-of-Way

(Curb Ramps)

Intersection ID: 18951	Main Street: BAKER_DR	Cross Street: TYVOLA_RD	Location: NE
ADA ID: DC805DBE3D98	Ramp Type: Combination2Diag	Initial Pass/Fail: Fail	Overall Compliance: No
		Severity Score: 0

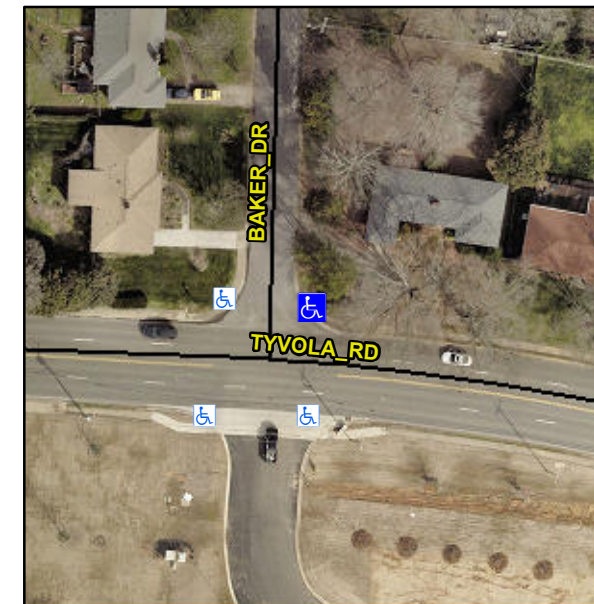
Compliance	Description	Data	Compliance	Description	Data
N/A	Ramp Length LT (in)	N/A	N/A	Ramp Length RT (in)	48.0
N/A	Ramp Width LT (in)	N/A	No	Ramp Width RT (in)	41.5
N/A	Ramp Slope LT (%)	N/A	No	Ramp Slope RT (%)	8.9
N/A	Ramp XSlope LT (%)	N/A	Yes	Ramp XSlope RT (%)	2.0
N/A	Ramp Length (in)	27.0	Yes	Ramp Slope (%)	5.3
Yes	Ramp Width (in)	48.0	Yes	Ramp XSlope (%)	0.2
N/A	Flare Type LT	N/A	N/A	Flare Type RT	N/A
N/A	Flare Slope LT (%)	N/A	N/A	Flare Slope RT (%)	N/A
N/A	Flare Traversable LT?	N/A	N/A	Flare Traversable RT?	N/A
N/A	Landing Length (in)	N/A	N/A	DWS Provided?	N/A
N/A	Landing Width (in)	N/A	N/A	DWS Contrast?	N/A
N/A	Landing Slope (%)	N/A	N/A	DWS Length (in)	N/A
N/A	Landing X Slope (%)	N/A	N/A	DWS Full Width?	N/A
N/A	Landing Curb? (Y/N)	N/A	N/A	DWS Offset (in)	N/A
N/A	Shared Landing?	N/A			
N/A	Gutter Ponding?	Yes	N/A	Gutter Slope (%)	N/A
N/A	Gutter Lip Ht (in)	N/A	N/A	Gutter X Slope (%)	N/A
N/A	Painted X Walk1?	No	N/A	Painted X Walk2?	No

X Walk 1 Direction	To W		X Walk 2 Direction	To S
	X Walk 1 Width (in)	N/A		X Walk 2 Width (in)	N/A
	X Walk 1 Slope (%)	5.0		X Walk 2 Slope (%)	5.1
	X Walk 1 X Slope (%)	1.1		X Walk 2 X Slope (%)	3.7
N/A	Ramp inside XWalk1?	N/A	N/A	Ramp inside XWalk2?	N/A
	Road Slope (%)	0.4		Clear Space?	N/A
	Road X Slope (%)	8.4	N/A	Clear Space to XWalk (in)	N/A
			N/A	Any Obstruction?	N/A
				Obstruction Type	N/A
			N/A	Storm Grate/Utility Hazard?	N/A
				Storm Grate/Utility Type	N/A
Yes	Surface Condition? (G/P)	Good			
	Curb Slope (%)	N/A

Remove & Replace Curb Ramp With Two New Directional Ramps or Equivalent.

R304.5.1, R304.3.2
