Access Compliance Report

Public Rights-of-Way

(Curb Ramps)

Intersection ID: 10033418	Main Street: OLD_HEBRON_RD	Cross Street: N/A	Location: SW
ADA ID: DC83FC8EB21B	Ramp Type: PerpDiag	Initial Pass/Fail: Fail	Overall Compliance: No
			Severity Score: 25

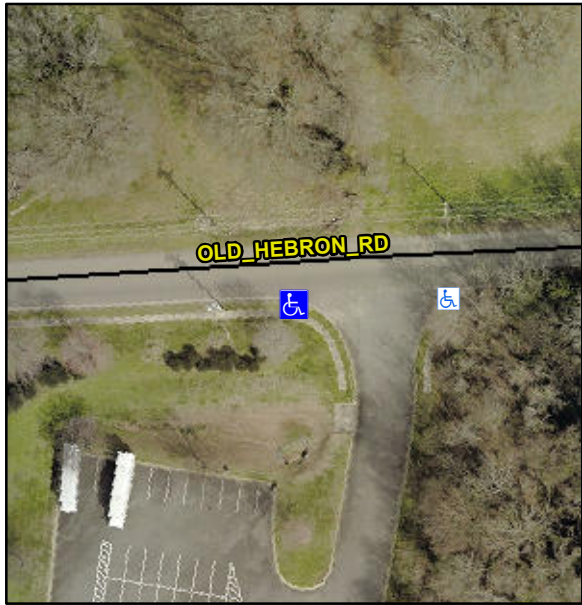
Possible Solutions:		Compliance	Description	Data	Compliance	Description	Data
	Remove & Replace Curb Ramp With Two New Directional Ramps or Equivalent.		N/A	Ramp Length (in)	48.0	No	Ramp Slope (%)	8.6
			Yes	Ramp Width (in)	48.0	No	Ramp XSlope (%)	5.4
			N/A	Flare Type LT	N/A	N/A	Flare Type RT	N/A
			N/A	Flare Slope LT (%)	N/A	N/A	Flare Slope RT (%)	N/A
			N/A	Flare Traversable LT?	N/A	N/A	Flare Traversable RT?	N/A
			N/A	Landing Length (in)	N/A	N/A	DWS Provided?	N/A
			N/A	Landing Width (in)	N/A	N/A	DWS Contrast?	N/A
			N/A	Landing Slope (%)	N/A	N/A	DWS Length (in)	N/A
			N/A	Landing X Slope (%)	N/A	N/A	DWS Full Width?	N/A
Surveyor Notes:	N/A		N/A	Landing Curb? (Y/N)	N/A	N/A	DWS Offset (in)	N/A
			N/A	Shared Landing?	N/A			
	PROW/ADA:		N/A	Gutter Ponding?	N/A	N/A	Gutter Slope (%)	N/A
	Not Found, R304.2.2, R304.5.3		N/A	Gutter Lip Ht (in)	N/A	N/A	Gutter X Slope (%)	N/A

N/A	Painted X Walk1?	No	N/A	Painted X Walk2?	No
				X Walk 1 Direction	To E		X Walk 2 Direction	To N
			N/A	X Walk 1 Width (in)	N/A	N/A	X Walk 2 Width (in)	N/A
				X Walk 1 Slope (%)	0.5		X Walk 2 Slope (%)	6.1
				X Walk 1 X Slope (%)	0.7		X Walk 2 X Slope (%)	4.1
			N/A	Ramp inside XWalk1?	N/A	N/A	Ramp inside XWalk2?	N/A
			Road Slope (%)	4.8	N/A	Clear Space?	N/A	
			Road X Slope (%)	2.4	N/A	Clear Space to XWalk (in)	N/A	
		N/A	Any Obstructions?	N/A	N/A	Storm Grate/Utility Hazard?	N/A	
			Obstruction Type			Storm Grate/Utility Type		
					N/A		N/A	
					Yes	Surface Condition? (G/P)	Good
