# Access Compliance Report

## Public Rights-of-Way

### (Curb Ramps)

Intersection ID: 44929	Main Street: TWIN_BROOK_DR	Cross Street: NATHAN_DR	Location:	E
ADA ID: DC8DDE7E7DE6	Ramp Type: Perp	Initial Pass/Fail: Pass	Overall Compliance: No	Severity Score: 0
Codes/Mitigation Info/Possible Solution		Field Measurements/Component Compliance

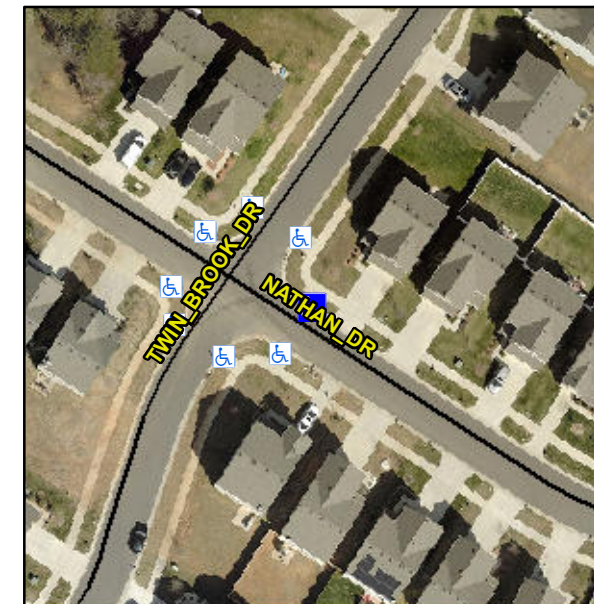
**Not Found, R305.2**

Compliance	Description	Data	Compliance	Description	Data
N/A	Ramp Length (in)	94.5	Yes	Ramp Slope (%)	5.9
Yes	Ramp Width (in)	59.5	Yes	Ramp XSlope (%)	0.4
N/A	Flare Type LT	Sloped	N/A	Flare Type RT	N/A
N/A	Flare Slope LT (%)	4.2	N/A	Flare Slope RT (%)	7.5
N/A	Flare Traversable LT?	No	N/A	Flare Traversable RT?	No
Yes	Landing Length (in)	59.5	Yes	DWS Provided?	Yes
Yes	Landing Width (in)	59.5	Yes	DWS Contrast?	Yes
Yes	Landing Slope (%)	0.9	Yes	DWS Length (in)	24.0
Yes	Landing X Slope (%)	0.1	Yes	DWS Full Width?	Yes
N/A	Landing Curb? (Y/N)	No	No	DWS Offset (in)	4.5
N/A	Shared Landing?	No			
Yes	Gutter Ponding?	No	Yes	Gutter Slope (%)	1.4
Yes	Gutter Lip Ht (in)	0.0	Yes	Gutter X Slope (%)	1.0
N/A	Painted X Walk1?	No	N/A	Painted X Walk2?	N/A
	X Walk 1 Direction	To SW		X Walk 2 Direction	N/A
N/A	X Walk 1 Width (in)	N/A	N/A	X Walk 2 Width (in)	N/A
	X Walk 1 Slope (%)	3.4		X Walk 2 Slope (%)	N/A
	X Walk 1 X Slope (%)	1.2		X Walk 2 X Slope (%)	N/A

N/A	Ramp inside XWalk1?	N/A	N/A	Ramp inside XWalk2?	N/A
	Road Slope (%)	N/A	N/A	Clear Space?	Yes
	Road X Slope (%)	N/A	N/A	Clear Space to XWalk (in)	N/A
Yes	Any Obstructions?	No	Yes	Storm Grate/Utility Hazard?	No
	Obstruction Type			Storm Grate/Utility Type	
		N/A			N/A
			Yes	Surface Condition? (G/P)	Good

**Remove & Replace Entire Ramp.**

Total Cost: \$ 1850.00
