Access Compliance Report

Public Rights-of-Way

(Curb Ramps)

Intersection ID: 50998	Main Street: S_TRYON_ST	Cross Street: STELECROFT_PY	Location: SW
ADA ID: DC958DF73F8E	Ramp Type: Perp	Initial Pass/Fail: Fail	Overall Compliance: No
			Severity Score: 13.75

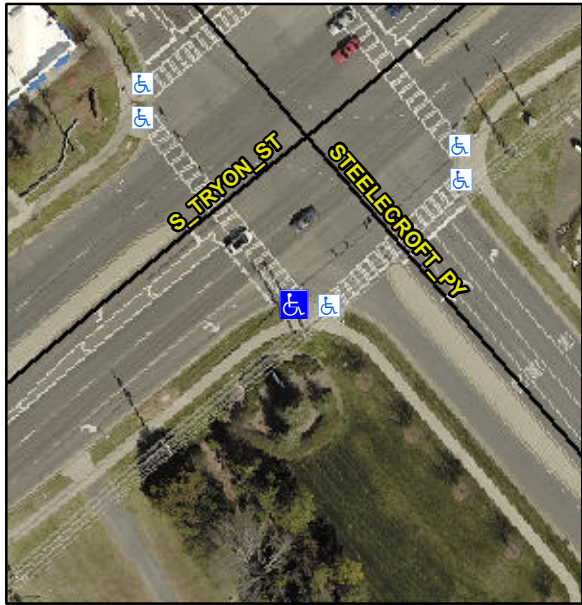
Possible Solutions:		Compliance	Description	Data	Compliance	Description	Data
	Remove & Replace Entire Ramp.		N/A	Ramp Length (in)	95.0	No	Ramp Slope (%)	10.2
			Yes	Ramp Width (in)	48.0	No	Ramp XSlope (%)	2.5
			N/A	Flare Type LT	N/A	N/A	Flare Type RT	N/A
			N/A	Flare Slope LT (%)	N/A	N/A	Flare Slope RT (%)	N/A
			N/A	Flare Traversable LT?	N/A	N/A	Flare Traversable RT?	N/A
			N/A	Landing Length (in)	N/A	N/A	DWS Provided?	N/A
			N/A	Landing Width (in)	N/A	N/A	DWS Contrast?	N/A
			N/A	Landing Slope (%)	N/A	N/A	DWS Length (in)	N/A
			N/A	Landing X Slope (%)	N/A	N/A	DWS Full Width?	N/A
Surveyor Notes:			N/A	Landing Curb? (Y/N)	N/A	N/A	DWS Offset (in)	N/A
N/A			N/A	Shared Landing?	N/A			
PROW/ADA:			N/A	Gutter Ponding?	N/A	N/A	Gutter Slope (%)	N/A
R304.2.2, R304.5.3			N/A	Gutter Lip Ht (in)	N/A	N/A	Gutter X Slope (%)	N/A

N/A	Painted X Walk1?	Yes	N/A	Painted X Walk2?	N/A
				X Walk 1 Direction	To NW		X Walk 2 Direction	N/A
			N/A	X Walk 1 Width (in)	111.0	N/A	X Walk 2 Width (in)	N/A
				X Walk 1 Slope (%)	2.0		X Walk 2 Slope (%)	N/A
				X Walk 1 X Slope (%)	1.7		X Walk 2 X Slope (%)	N/A
			N/A	Ramp inside XWalk1?	Yes	N/A	Ramp inside XWalk2?	N/A
				Road Slope (%)	N/A	N/A	Clear Space?	N/A
				Road X Slope (%)	N/A	N/A	Clear Space to XWalk (in)	N/A
			N/A	Any Obstructions?	N/A	N/A	Storm Grate/Utility Hazard?	N/A
				Obstruction Type			Storm Grate/Utility Type	
					N/A			N/A
						Yes	Surface Condition? (G/P)	Good
