# Access Compliance Report

## Public Rights-of-Way

### (Curb Ramps)

Intersection ID: 23663	Main Street: S_TRYON_ST	Cross Street: ERWIN_RD	Location: W
ADA ID: DC9A039D5F64	Ramp Type: MedianPerp	Initial Pass/Fail: Pass	Overall Compliance: No
Severity Score: 2.5			
Codes/Mitigation Info/Possible Solution		Field Measurements/Component Compliance

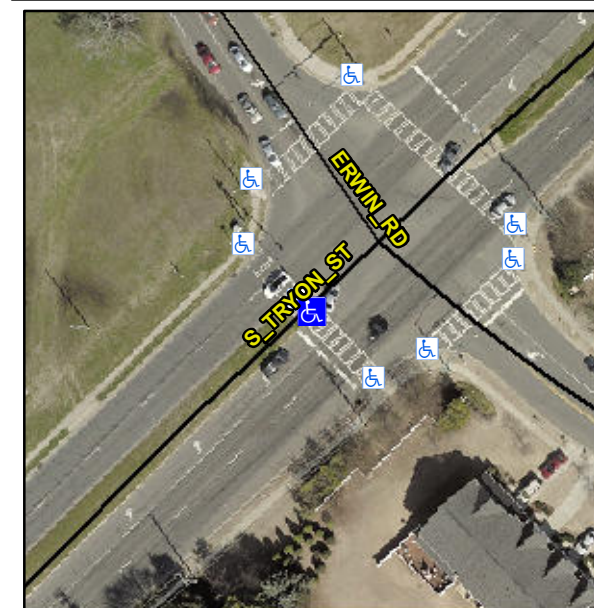
**Not Found, R304.2.1, R304.2.2-Perp, R304.3.2-Para, R305.1.4**

Compliance	Description	Data	Compliance	Description	Data
N/A	Ramp Length (in)	44.0	Yes	Ramp Slope (%)	6.7
Yes	Ramp Width (in)	48.0	Yes	Ramp XSlope (%)	1.2
N/A	Flare Type LT	Sloped	N/A	Flare Type RT	N/A
N/A	Flare Slope LT (%)	5.8	N/A	Flare Slope RT (%)	2.0
N/A	Flare Traversable LT?	No	N/A	Flare Traversable RT?	No
Yes	Landing Length (in)	60.0	Yes	DWS Provided?	Yes
No	Landing Width (in)	47.5	Yes	DWS Contrast?	Yes
No	Landing Slope (%)	2.9	Yes	DWS Length (in)	24.5
Yes	Landing X Slope (%)	0.1	No	DWS Full Width?	No
N/A	Landing Curb? (Y/N)	N/A	Yes	DWS Offset (in)	0.0
N/A	Shared Landing?	Yes			
Yes	Gutter Ponding?	No	Yes	Gutter Slope (%)	4.4
Yes	Gutter Lip Ht (in)	0.0	Yes	Gutter X Slope (%)	1.4
N/A	Painted X Walk1?	Yes	N/A	Painted X Walk2?	N/A
	X Walk 1 Direction	To S		X Walk 2 Direction	N/A
N/A	X Walk 1 Width (in)	120.0	N/A	X Walk 2 Width (in)	N/A
	X Walk 1 Slope (%)	1.3		X Walk 2 Slope (%)	N/A
	X Walk 1 X Slope (%)	1.5		X Walk 2 X Slope (%)	N/A

Yes	Ramp inside XWalk1?	Yes	N/A	Ramp inside XWalk2?	N/A
	Road Slope (%)	N/A	N/A	Clear Space?	Yes
	Road X Slope (%)	N/A	N/A	Clear Space to XWalk (in)	N/A
Yes	Any Obstructions?	No	Yes	Storm Grate/Utility Hazard?	No
	Obstruction Type			Storm Grate/Utility Type	
		N/A			N/A
			Yes	Surface Condition? (G/P)	Good

**Remove & Replace Entire Ramp.**
