# Access Compliance Report

## Public Rights-of-Way

### (Curb Ramps)

| Intersection ID: 10025543 | Main Street: E_TRADE_ST | Cross Street: N/A | Location: W |

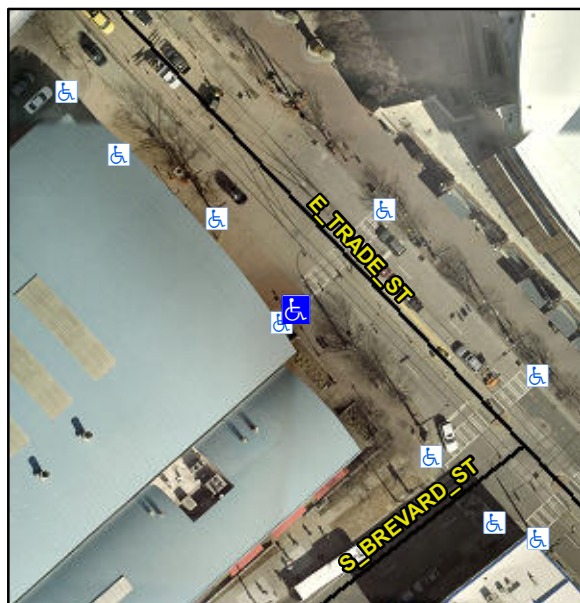
**R304.5.3, R304.5.2**

| Compliance | Description | Data | Compliance | Description | Data |
|---|---|---|---|---|---|
| N/A | Ramp Length (in) | 76.0 | No | Grade Break? | No |
| No | Ramp XSlope (%) | 2.9 | | | |
| No | Landing X Slope (%) | 5.2 | Yes | DWS Full Width? | Yes |
| Yes | Gutter Lip Ht (in) | 0.0 | No | Gutter X Slope (%) | 3.5 |

**Remove & Replace Entire Ramp.  
Remove & Replace Gutter.**

Total Cost: \$ 2350.00

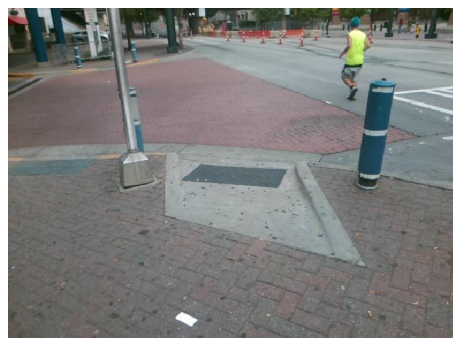
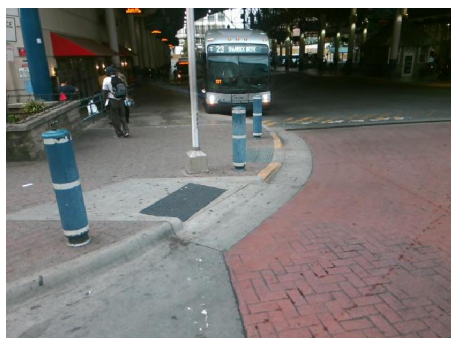
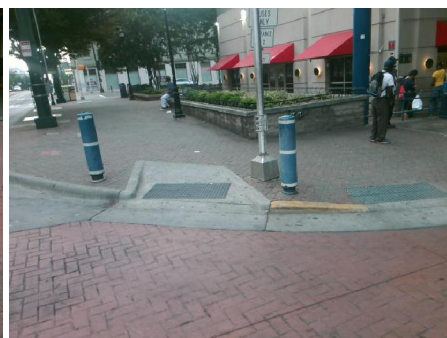
| ADA ID: DCA0B854A099 | Ramp Type: Directional1 | Initial Pass/Fail: Pass | Overall Compliance: No |
| Severity Score: 0.25 | | | |
