Access Compliance Report

Public Rights-of-Way

(Curb Ramps)

Intersection ID: 10037433	Main Street: SCOTLAND_HALL_CT	Cross Street: N/A	Location: SE
ADA ID: DCA330A7549A	Ramp Type: Perp	Initial Pass/Fail: Fail	Overall Compliance: No
Codes/Mitigation Info/Possible Solution		Field Measurements/Component Compliance	
Severity Score: 33.75

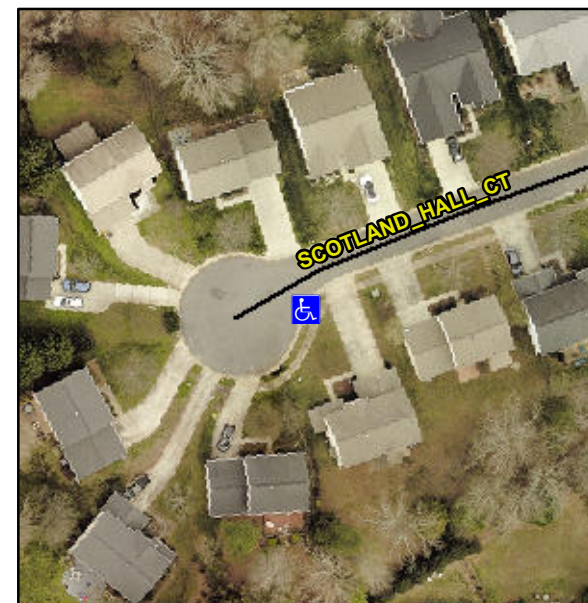
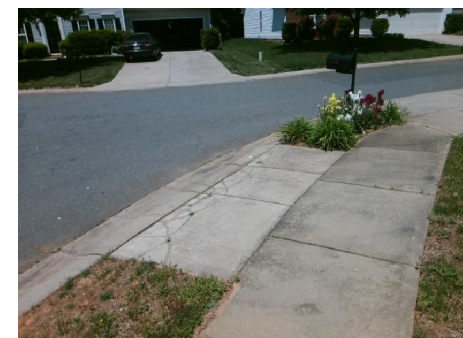
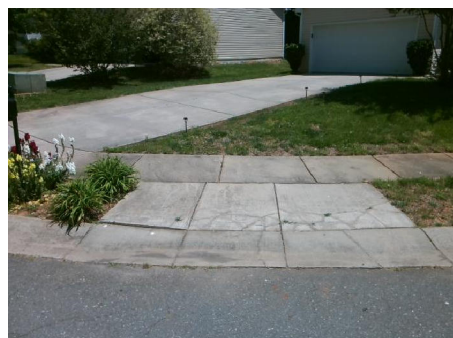
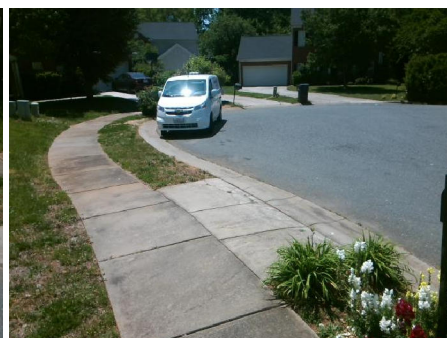
Not Found, R304.5.1, R304.2.2

Compliance	Description	Data	Compliance	Description	Data
N/A	Ramp Length (in)	46.5	No	Ramp Slope (%)	13.3
No	Ramp Width (in)	36.0	Yes	Ramp XSlope (%)	0.9
N/A	Flare Type LT	N/A	N/A	Flare Type RT	N/A
N/A	Flare Slope LT (%)	N/A	N/A	Flare Slope RT (%)	N/A
N/A	Flare Traversable LT?	N/A	N/A	Flare Traversable RT?	N/A
N/A	Landing Length (in)	N/A	N/A	DWS Provided?	N/A
N/A	Landing Width (in)	N/A	N/A	DWS Contrast?	N/A
N/A	Landing Slope (%)	N/A	N/A	DWS Length (in)	N/A
N/A	Landing X Slope (%)	N/A	N/A	DWS Full Width?	N/A
N/A	Landing Curb? (Y/N)	N/A	N/A	DWS Offset (in)	N/A
N/A	Shared Landing?	N/A			
N/A	Gutter Ponding?	N/A	N/A	Gutter Slope (%)	N/A
N/A	Gutter Lip Ht (in)	N/A	N/A	Gutter X Slope (%)	N/A
N/A	Painted X Walk1?	No	N/A	Painted X Walk2?	N/A
	X Walk 1 Direction	To N		X Walk 2 Direction	N/A
N/A	X Walk 1 Width (in)	N/A	N/A	X Walk 2 Width (in)	N/A
	X Walk 1 Slope (%)	3.4		X Walk 2 Slope (%)	N/A
	X Walk 1 X Slope (%)	1.7		X Walk 2 X Slope (%)	N/A

N/A	Ramp inside XWalk1?	N/A	N/A	Ramp inside XWalk2?	N/A
	Road Slope (%)	1.7	N/A	Clear Space?	N/A
	Road X Slope (%)	3.4	N/A	Clear Space to XWalk (in)	N/A
N/A	Any Obstructions?	N/A	N/A	Storm Grate/Utility Hazard?	N/A
	Obstruction Type			Storm Grate/Utility Type	
		N/A			N/A
			Yes	Surface Condition? (G/P)	Good

Remove & Replace Entire Ramp.
