# Access Compliance Report

## Public Rights-of-Way

### (Curb Ramps)

| Intersection ID: N/A | Main Street: ARBOR_LOOP_DR | Cross Street: POTOMAC_RIVER_PY | Location: SE |

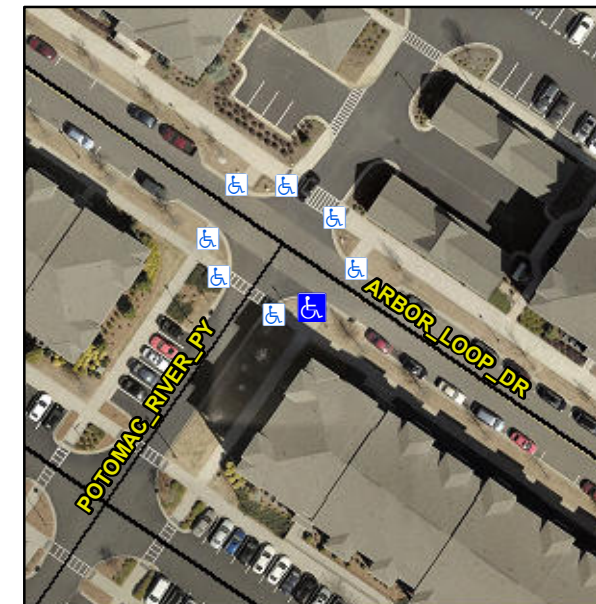
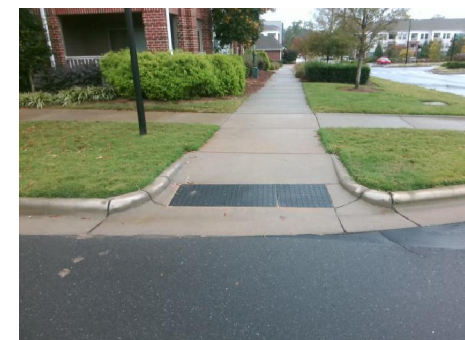
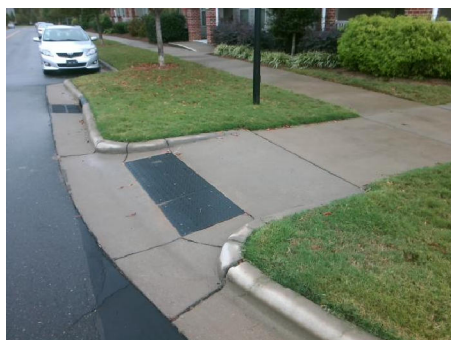
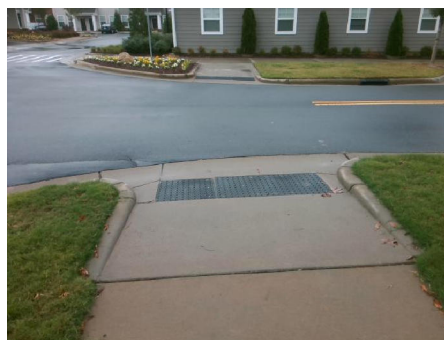
| ADA ID: DCA5C6791E2B | Ramp Type: BlendTrans1 | Initial Pass/Fail: Pass | Overall Compliance: No |

**Not Found, R304.2.2-Perp, R304.3.2-Para, R305.1.4, R304.5.4**

| Compliance | Description | Data | Compliance | Description | Data |
|---|---|---|---|---|---|
| No | Landing Slope (%) | 4.3 | Yes | DWS Length (in) | 24.0 |
| Yes | Landing X Slope (%) | 0.6 | No | DWS Full Width? | No |
| Yes | Gutter Ponding? | No | No | Gutter Slope (%) | 5.3 |
| | | | No | Curb Slope (%) | 5.4 |

**Remove & Replace Curb Ramp With Two New Directional Ramps or Equivalent. Remove & Replace Gutter.**
