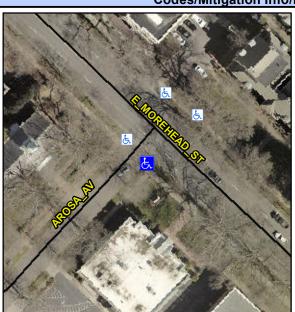
Total Cost: 3200.00

Comp	oliance	Description	Data	Comp	liance	Description	Data
N/A	Ramı	p Length (in)	80.0	No	Ramp	Slope (%)	10.2
Yes	Ramı	p Width (in)	48.0	No	Ram	XSlope (%)	2.9
N/A	Flare	Type LT	N/A	N/A	Flare	Type RT	N/A
N/A	Flare	Slope LT (%)	N/A	N/A	Flare	Slope RT (%)	N/A
N/A	Flare	Traversable LT?	N/A	N/A	Flare	Traversable RT?	N/A
N/A	Land	ing Length (in)	N/A	N/A	DWS	Provided?	N/A
N/A	Land	ing Width (in)	N/A	N/A	DWS	Contrast?	N/A
N/A	Land	ing Slope (%)	N/A	N/A	DWS	Length (in)	N/A
N/A	Land	ing X Slope (%)	N/A	N/A	DWS	Full Width?	N/A
N/A	Land	ing Curb? (Y/N)	N/A	N/A	DWS	Offset (in)	N/A
N/A	Share	ed Landing?	N/A				
N/A	Gutte	er Ponding?	N/A	N/A	Gutte	er Slope (%)	N/A
N/A	Gutte	er Lip Ht (in)	N/A	N/A	Gutte	er X Slope (%)	N/A
N/A	Paint	ed X Walk1?	No	N/A	Paint	ed X Walk2?	No
	X Wa	ılk 1 Direction	To NE		X Wa	lk 2 Direction	To NW
N/A	X Wa	ılk 1 Width (in)	N/A	N/A	X Wa	lk 2 Width (in)	N/A
	X Wa	ılk 1 Slope (%)	3.3		X Wa	lk 2 Slope (%)	6.4

Street 1 Name Stop Condition-Street 2 Street 2 Name Stop Condition-Street 1 E MOREHEAD ST None AROSA AV StopSign

N/A
100	PROW/ADA: Not Found, R304
Т	
е	
V	
n	
	T
