Access Compliance Report Public Rights-of-Way (Curb Ramps)

Intersection ID: 11299 Main Street: S SUMMIT AV Cross Street: W_4TH_ST Location:

Overall Compliance: No ADA ID: DCADB1EC0EE2 Ramp Type: PerpDiag Initial Pass/Fail: Fail **Severity Score:** 17.5

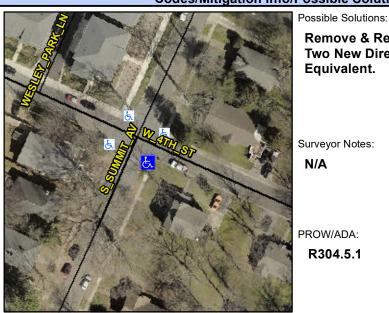
Compliance Description		Data	Comp	liance Description	Data
N/A	Ramp Length (in)	53.0	Yes	Ramp Slope (%)	5.0
No	Ramp Width (in)	34.5	Yes	Ramp XSlope (%)	1.3
N/A	Flare Type LT	N/A	N/A	Flare Type RT	N/A
N/A	Flare Slope LT (%)	N/A	N/A	Flare Slope RT (%)	N/A
N/A	Flare Traversable LT?	N/A	N/A	Flare Traversable RT?	N/A
N/A	Landing Length (in)	N/A	N/A	DWS Provided?	N/A
N/A	Landing Width (in)	N/A	N/A	DWS Contrast?	N/A
N/A	Landing Slope (%)	N/A	N/A	DWS Length (in)	N/A
N/A	Landing X Slope (%)	N/A	N/A	DWS Full Width?	N/A
N/A	Landing Curb? (Y/N)	N/A	N/A	DWS Offset (in)	N/A
N/A	Shared Landing?	N/A			
N/A	Gutter Ponding?	Yes	N/A	Gutter Slope (%)	N/A
N/A	Gutter Lip Ht (in)	N/A	N/A	Gutter X Slope (%)	N/A
N/A	Painted X Walk1?	No	N/A	Painted X Walk2?	No
	X Walk 1 Direction	To NE		X Walk 2 Direction	To NW
N/A	X Walk 1 Width (in)	N/A	N/A	X Walk 2 Width (in)	N/A
	X Walk 1 Slope (%)	1.6		X Walk 2 Slope (%)	3.3
	X Walk 1 X Slope (%)	1.8		X Walk 2 X Slope (%)	1.1

N/A	Ramp inside XWalk1?	N/A	N/A	Ramp inside XWalk2?	N/A
	Road Slope (%)	0.8	N/A	Clear Space?	N/A
	Road X Slope (%)	5.1	N/A	Clear Space to XWalk (in)	N/A
•	Any Obstructions?	N/A	N/A	Storm Grate/Utility Hazard?	N/A
	Obstruction Type			Storm Grate/Utility Type	
			I

Street 1 Name Stop Condition-Street 2 Street 2 Name Stop Condition-Street 1 Remove & Replace Curb Ramp With Two New Directional Ramps or Equivalent.

R304.5.1

Total Cost: 3200.00
