Access Compliance Report

Public Rights-of-Way

(Curb Ramps)

Intersection ID: 43367	Main Street: ROUDA_LN	Cross Street: SIMONTON_DR	Location: W
ADA ID: DCB64560F935	Ramp Type: Perp	Initial Pass/Fail: Fail	Overall Compliance: No
Codes/Mitigation Info/Possible Solution		Field Measurements/Component Compliance

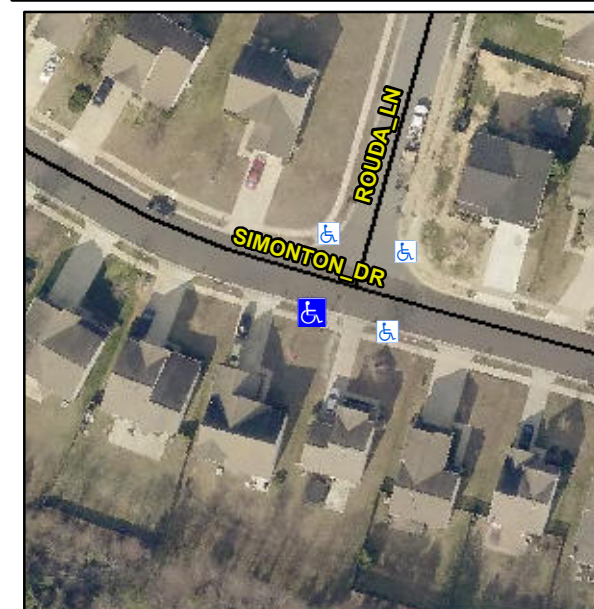
Not Found, R304.2.2

Compliance	Description	Data	Compliance	Description	Data
N/A	Ramp Length (in)	48.0	No	Ramp Slope (%)	11.4
Yes	Ramp Width (in)	48.0	Yes	Ramp XSlope (%)	4.9
N/A	Flare Type LT	N/A	N/A	Flare Type RT	N/A
N/A	Flare Slope LT (%)	N/A	N/A	Flare Slope RT (%)	N/A
N/A	Flare Traversable LT?	N/A	N/A	Flare Traversable RT?	N/A
N/A	Landing Length (in)	N/A	N/A	DWS Provided?	N/A
N/A	Landing Width (in)	N/A	N/A	DWS Contrast?	N/A
N/A	Landing Slope (%)	N/A	N/A	DWS Length (in)	N/A
N/A	Landing X Slope (%)	N/A	N/A	DWS Full Width?	N/A
N/A	Landing Curb? (Y/N)	N/A	N/A	DWS Offset (in)	N/A
N/A	Shared Landing?	N/A			
N/A	Gutter Ponding?	N/A	N/A	Gutter Slope (%)	N/A
N/A	Gutter Lip Ht (in)	N/A	N/A	Gutter X Slope (%)	N/A
N/A	Painted X Walk1?	No	N/A	Painted X Walk2?	N/A
	X Walk 1 Direction	To NE		X Walk 2 Direction	N/A
N/A	X Walk 1 Width (in)	N/A	N/A	X Walk 2 Width (in)	N/A
	X Walk 1 Slope (%)	3.6		X Walk 2 Slope (%)	N/A
	X Walk 1 X Slope (%)	4.9		X Walk 2 X Slope (%)	N/A

N/A	Ramp inside XWalk1?	N/A	N/A	Ramp inside XWalk2?	N/A
	Road Slope (%)	N/A	N/A	Clear Space?	N/A
	Road X Slope (%)	N/A	N/A	Clear Space to XWalk (in)	N/A
N/A	Any Obstructions?	N/A	N/A	Storm Grate/Utility Hazard?	N/A
	Obstruction Type			Storm Grate/Utility Type	
		N/A			N/A
			Yes	Surface Condition? (G/P)	Good

Remove & Replace Entire Ramp.

Total Cost: \$ 1850.00
