Access Compliance Report Public Rights-of-Way (Curb Ramps)

Intersection ID: 32097 Main Street: JERPOINT ABBY DR Cross Street: ROTHE HOUSE RD Location: NE **ADA ID: DCBDBFD019AC** Ramp Type: BlendTrans1 Initial Pass/Fail: Fail **Overall Compliance: No Severity Score:** 42.5

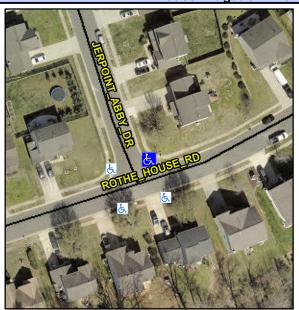
Compliance Description Date		Data	Comp	liance Description	Data
N/A	Ramp Length (in)	47.5	Yes	BlendTrans Slope (%)	3.8
No	Ramp Width (in)	33.0	No	BlendTrans XSlope (%)	10.1
N/A	Flare Type LT	N/A	N/A	Flare Type RT	N/A
N/A	Flare Slope LT (%)	N/A	N/A	Flare Slope RT (%)	N/A
N/A	Flare Traversable LT?	N/A	N/A	Flare Traversable RT?	N/A
N/A	Landing Length (in)	N/A	N/A	DWS Provided?	N/A
N/A	Landing Width (in)	N/A	N/A	DWS Contrast?	N/A
N/A	Landing Slope (%)	N/A	N/A	DWS Length (in)	N/A
N/A	Landing X Slope (%)	N/A	N/A	DWS Full Width?	N/A
N/A	Landing Curb? (Y/N)	N/A	N/A	DWS Offset (in)	N/A
N/A	Shared Landing?	N/A			
N/A	Gutter Ponding?	N/A	N/A	Gutter Slope (%)	N/A
N/A	Gutter Lip Ht (in)	N/A	N/A	Gutter X Slope (%)	N/A
N/A	Painted X Walk1?	No	N/A	Painted X Walk2?	No
	X Walk 1 Direction	To SW		X Walk 2 Direction	To SE
	X Walk 1 Width (in)	N/A		X Walk 2 Width (in)	N/A
	X Walk 1 Slope (%)	9.2		X Walk 2 Slope (%)	2.0
	X Walk 1 X Slope (%)	0.1		X Walk 2 X Slope (%)	10.4

N/A	Ramp inside XWalk1?	N/A	N/A	Ramp inside XWalk2?	N/A
	Road Slope (%)	8.7		Clear Space?	N/A
	Road X Slope (%)	10.8	N/A	Clear Space to XWalk (in)	N/A
N/A	Any Obstructions?	N/A	N/A	Storm Grate/Utility Hazard?	N/A
	Obstruction Type		l	Storm Grate/Utility Type	
		N/A	l		N/A
			Yes	Surface Condition? (G/P)	Good
177/619			N/A	Curb Slope (%)	0.4

Possible Solutions: **Remove & Replace Curb Ramp With Two New Directional Ramps or** Equivalent. Surveyor Notes: N/A PROW/ADA: R304.5.1, R304.5.3
