Access Compliance Report

Public Rights-of-Way

(Curb Ramps)

Intersection ID: 15444	Main Street: SOUTH_BV	Cross Street: RAIL_CROSSING_LN	Location: W
ADA ID: DCC0D8F50D76	Ramp Type: Perp	Initial Pass/Fail: Pass	Overall Compliance: No
			Severity Score: 10.25

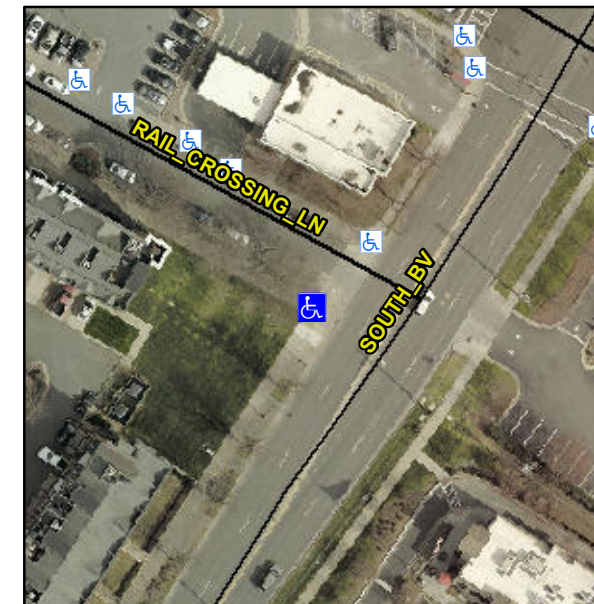
Compliance	Description	Data	Compliance	Description	Data
N/A	Ramp Length (in)	48.0	Yes	Ramp Slope (%)	5.4
Yes	Ramp Width (in)	48.0	No	Ramp XSlope (%)	4.1
N/A	Flare Type LT	Sloped	N/A	Flare Type RT	N/A
N/A	Flare Slope LT (%)	0.1	Yes	Flare Slope RT (%)	2.6
N/A	Flare Traversable LT?	Yes	N/A	Flare Traversable RT?	Yes
Yes	Landing Length (in)	48.0	No	DWS Provided?	No
Yes	Landing Width (in)	48.0	N/A	DWS Contrast?	No
No	Landing Slope (%)	3.2	N/A	DWS Length (in)	N/A
No	Landing X Slope (%)	3.2	N/A	DWS Full Width?	No
N/A	Landing Curb? (Y/N)	No	N/A	DWS Offset (in)	N/A
N/A	Shared Landing?	No			
Yes	Gutter Ponding?	No	Yes	Gutter Slope (%)	0.5
Yes	Gutter Lip Ht (in)	0.0	No	Gutter X Slope (%)	2.3
N/A	Painted X Walk1?	No	N/A	Painted X Walk2?	N/A
	X Walk 1 Direction	To NE		X Walk 2 Direction	N/A
N/A	X Walk 1 Width (in)	N/A	N/A	X Walk 2 Width (in)	N/A
	X Walk 1 Slope (%)	1.4		X Walk 2 Slope (%)	N/A
	X Walk 1 X Slope (%)	1.4		X Walk 2 X Slope (%)	N/A

N/A	Ramp inside XWalk1?	N/A	N/A	Ramp inside XWalk2?	N/A
	Road Slope (%)	N/A	N/A	Clear Space?	Yes
	Road X Slope (%)	N/A	N/A	Clear Space to XWalk (in)	N/A
Yes	Any Obstructions?	No	Yes	Storm Grate/Utility Hazard?	No
	Obstruction Type			Storm Grate/Utility Type	
		N/A			N/A
			Yes	Surface Condition? (G/P)	Good

Possible Solutions:

**Remove & Replace Entire Ramp.
Remove & Replace Gutter.**
