# Access Compliance Report

## Public Rights-of-Way

Intersection ID: 9748	Main Street: GLENWOOD_DR	Cross Street: HASHEM_DR	Location:	N
ADA ID: DCC58AC0798E	Ramp Type: Perp	Initial Pass/Fail: Fail	Overall Compliance: No	Severity Score: 21.25

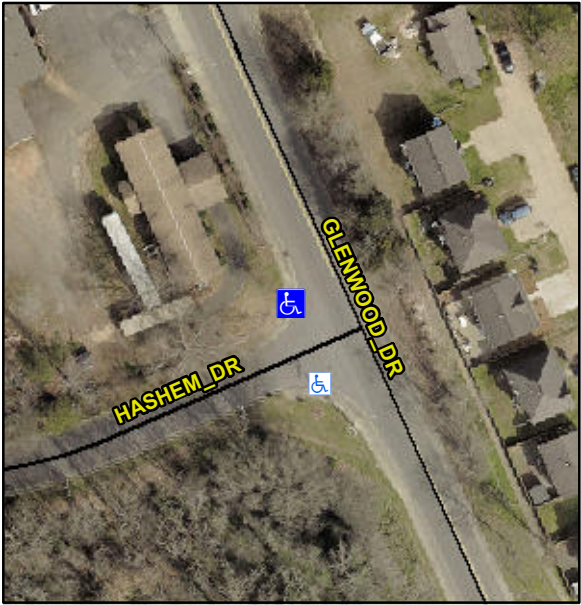
Possible Solutions:		<b>Compliance</b>	<b>Description</b>	<b>Data</b>
	<b>Remove &amp; Replace Entire Ramp.</b>		<b>No</b>	Ramp Length (in)	60.0
			<b>No</b>	Ramp Width (in)	44.5
			<b>N/A</b>	Flare Type LT	N/A
			<b>N/A</b>	Flare Slope LT (%)	N/A
			<b>N/A</b>	Flare Traversable LT?	N/A
			<b>N/A</b>	Landing Length (in)	N/A
			<b>N/A</b>	Landing Width (in)	N/A
			<b>N/A</b>	Landing Slope (%)	N/A
			<b>N/A</b>	Landing X Slope (%)	N/A
<p>Surveyor Notes:</p> <p><b>N/A</b></p> <p>PROW/ADA:</p> <p><b>Not Found, R304.5.1, R304.2.2</b></p>			<b>N/A</b>	Flare Type RT	N/A
			<b>N/A</b>	Flare Slope RT (%)	N/A
			<b>N/A</b>	Flare Traversable RT?	N/A
			<b>N/A</b>	DWS Provided?	N/A
			<b>N/A</b>	DWS Contrast?	N/A
			<b>N/A</b>	DWS Length (in)	N/A
			<b>N/A</b>	DWS Full Width?	N/A
			<b>N/A</b>	DWS Offset (in)	N/A
			<b>N/A</b>	Shared Landing?	N/A

<b>N/A</b>	Gutter Ponding?	N/A
			<b>N/A</b>	Gutter Lip Ht (in)	N/A
			<b>N/A</b>	Painted X Walk1?	No
				X Walk 1 Direction	To S
			<b>N/A</b>	X Walk 1 Width (in)	N/A
				X Walk 1 Slope (%)	0.8
				X Walk 1 X Slope (%)	1.4
			<b>N/A</b>	Ramp inside XWalk1?	N/A
			<b>N/A</b>	Road Slope (%)	N/A
			<b>N/A</b>	Road X Slope (%)	N/A
			<b>N/A</b>	Any Obstructions?	N/A
Total Cost:		\$ 1850.00		Obstruction Type	
			<b>N/A</b>		
			<b>Yes</b>	Surface Condition? (G/P)	Good
