Access Compliance Report Public Rights-of-Way (Curb Ramps)

Intersection ID: N/A Main Street: STEELE_CREEK_RD Cross Street: N/A Location: NW **Overall Compliance: No** ADA ID: DCC8A3862C2E Ramp Type: Perp Initial Pass/Fail: Fail **Severity Score:** 12.5

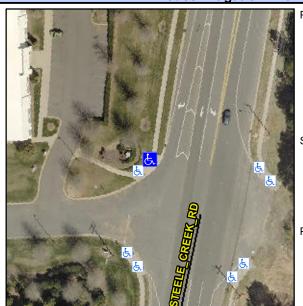
Field Measurements/Component Compliance									
Compli	ance Description	Data	Compli	ance	Description	Data			
N/A	Ramp Length (in)	60.0	No	Ramp	Slope (%)	8.6			
Yes	Ramp Width (in)	59.0	Yes	Ramp	XSlope (%)	0.9			
N/A	Flare Type LT	N/A	N/A	Flare	Type RT	N/A			
N/A	Flare Slope LT (%)	N/A	N/A	I/A Flare Slope RT (%)		N/A			
N/A	Flare Traversable LT?	N/A	N/A	Flare Traversable RT?		N/A			
N/A	Landing Length (in)	N/A	N/A	DWS Provided?		N/A			
N/A	Landing Width (in)	N/A	N/A	DWS	Contrast?	N/A			
N/A	Landing Slope (%)	N/A	N/A	DWS	Length (in)	N/A			
N/A	Landing X Slope (%)	N/A	N/A	DWS	Full Width?	N/A			
N/A	Landing Curb? (Y/N)	N/A	N/A	DWS	Offset (in)	N/A			
N/A	Shared Landing?	N/A							
N/A	Gutter Ponding?	N/A	N/A	Gutte	r Slope (%)	N/A			
N/A	Gutter Lip Ht (in)	N/A	N/A	Gutte	r X Slope (%)	N/A			
N/A	Painted X Walk1?	No	N/A	Painte	ed X Walk2?	N/A			
	X Walk 1 Direction	To SE		X Wa	lk 2 Direction	N/A			
N/A	X Walk 1 Width (in)	N/A	N/A	X Wa	lk 2 Width (in)	N/A

X Walk 1 Slope (%)	2.5		X Wa	lk 2 Slope (%)	N/A			
	X Walk 1 X Slope (%)	8.0		X Wa	lk 2 X Slope (%)	N/A			
N/A	Ramp inside XWalk1?	N/A	N/A	Ramp	inside XWalk2?	N/A			
	Road Slope (%)	N/A	N/A	Clear	Space?	N/A			
	Road X Slope (%)	N/A	N/A	Clear	Space to XWalk (in)	N/A			
N/A	Any Obstructions?	N/A	N/A	Storm	Grate/Utility Hazard?	N/A			
	Obstruction Type			Storm	Grate/Utility Type				
		N/A				N/A			
			Yes	Surfa	ce Condition? (G/P)	Good

Possible Solutions:							
Remove & Replace Entire Ramp.							
•							
Surveyor Notes:							
N/A							
PROW/ADA:							
Not Found, R304.2.2							
,

Not Found, R304.2.2	
Total Cost:	\$ 1850.00
