Access Compliance Report

Public Rights-of-Way

(Curb Ramps)

Intersection ID: 16691	Main Street: WALKER_RD	Cross Street: MILLBROOK_RD	Location: NW
ADA ID: DCCAAC36E866	Ramp Type: PerpDiag	Initial Pass/Fail: Fail	Overall Compliance: No
Codes/Mitigation Info/Possible Solution		Field Measurements/Component Compliance	
		Severity Score: 10

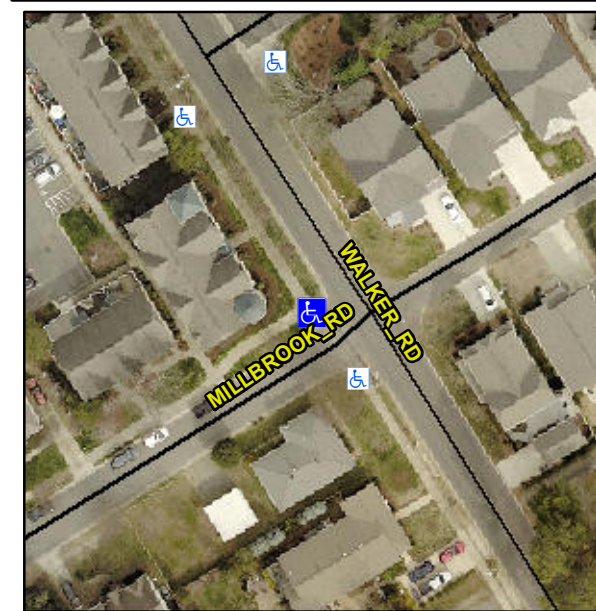
R304.5.1, R304.5.3

Compliance	Description	Data	Compliance	Description	Data
N/A	Ramp Length (in)	25.5	Yes	Ramp Slope (%)	8.2
No	Ramp Width (in)	45.0	No	Ramp XSlope (%)	4.7
N/A	Flare Type LT	N/A	N/A	Flare Type RT	N/A
N/A	Flare Slope LT (%)	N/A	N/A	Flare Slope RT (%)	N/A
N/A	Flare Traversable LT?	N/A	N/A	Flare Traversable RT?	N/A
N/A	Landing Length (in)	N/A	N/A	DWS Provided?	N/A
N/A	Landing Width (in)	N/A	N/A	DWS Contrast?	N/A
N/A	Landing Slope (%)	N/A	N/A	DWS Length (in)	N/A
N/A	Landing X Slope (%)	N/A	N/A	DWS Full Width?	N/A
N/A	Landing Curb? (Y/N)	N/A	N/A	DWS Offset (in)	N/A
N/A	Shared Landing?	N/A			
N/A	Gutter Ponding?	N/A	N/A	Gutter Slope (%)	N/A
N/A	Gutter Lip Ht (in)	N/A	N/A	Gutter X Slope (%)	N/A
N/A	Painted X Walk1?	No	N/A	Painted X Walk2?	No
	X Walk 1 Direction	To SE		X Walk 2 Direction	To E
N/A	X Walk 1 Width (in)	N/A	N/A	X Walk 2 Width (in)	N/A
	X Walk 1 Slope (%)	4.1		X Walk 2 Slope (%)	0.3
	X Walk 1 X Slope (%)	2.7		X Walk 2 X Slope (%)	3.1

N/A	Ramp inside XWalk1?	N/A	N/A	Ramp inside XWalk2?	N/A
	Road Slope (%)	2.4	N/A	Clear Space?	N/A
	Road X Slope (%)	2.5	N/A	Clear Space to XWalk (in)	N/A
N/A	Any Obstructions?	N/A	N/A	Storm Grate/Utility Hazard?	N/A
	Obstruction Type			Storm Grate/Utility Type	
		N/A			N/A
		Yes		Surface Condition? (G/P)	Good

Possible Solutions:

Remove & Replace Curb Ramp With Two New Directional Ramps or Equivalent.
