## **Access Compliance Report Public Rights-of-Way** (Curb Ramps)

Main Street: FAWN LILY Intersection ID: 50615 Cross Street: BALSAM BAY RD Location: NW **Overall Compliance: No** ADA ID: DCCDB76B645D Ramp Type: Perp Initial Pass/Fail: Fail Severity Score: 13.75

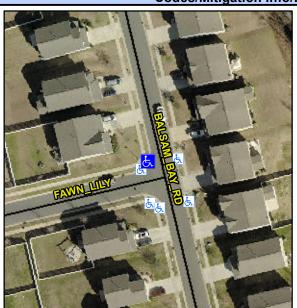
8.9

4.7

Ramp Slope (%)

Ramp XSlope (%)

Possible Solutions:	Compli	iance Description
Remove & Replace Entire Ramp.	N/A	Ramp Length (in)
·	Yes	Ramp Width (in)
	N/A	Flare Type LT
	N/A	Flare Slope LT (%)
	N/A	Flare Traversable L
	N/A	Landing Length (in)
Surveyor Notes:	N/A	Landing Width (in)
N/A	N/A	Landing Slope (%)
	N/A	Landing X Slope (%
	N/A	Landing Curb? (Y/N
	N/A	Shared Landing?
PROW/ADA:	N/A	Gutter Ponding?
R304.2.2, R304.5.3	N/A	Gutter Lip Ht (in)
	N/A	Painted X Walk1?
		X Walk 1 Direction
	N/A	X Walk 1 Width (in)
		X Walk 1 Slope (%)
		X Walk 1 X Slope (%
	N/A	Ramp inside XWalk
		Dood Clans (0/)
