Access Compliance Report

Public Rights-of-Way

(Curb Ramps)

Intersection ID: 9092	Main Street: KALYNNE_ST	Cross Street: LAKEWOOD_AV	Location: E
ADA ID: DCD776C420ED	Ramp Type: Perp	Initial Pass/Fail: Fail	Overall Compliance: No
Severity Score: 37.5			
Codes/Mitigation Info/Possible Solution		Field Measurements/Component Compliance

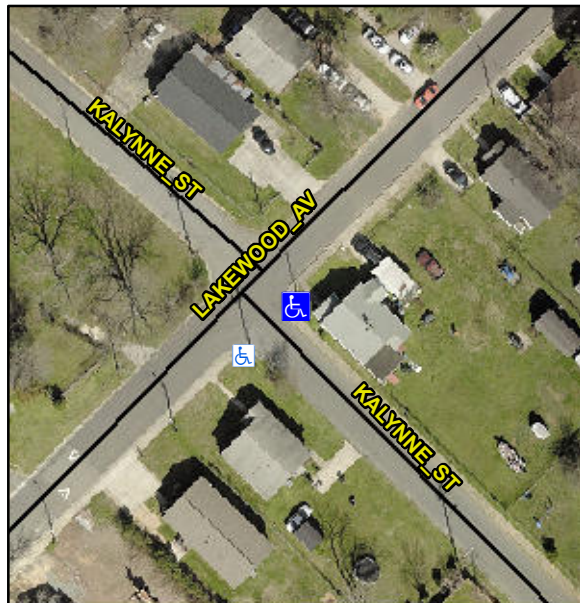
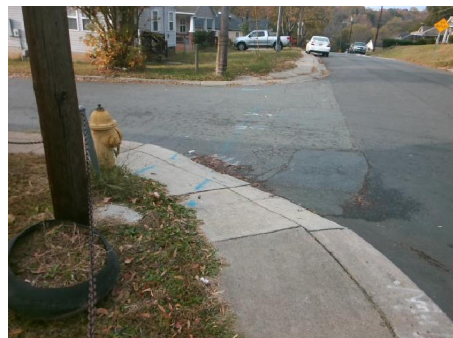
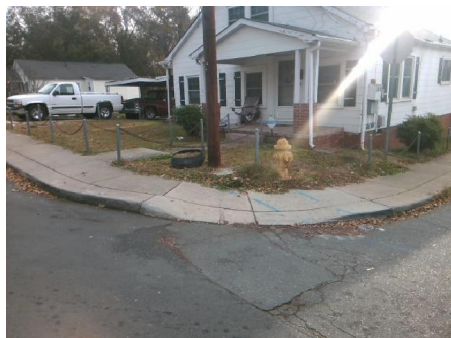
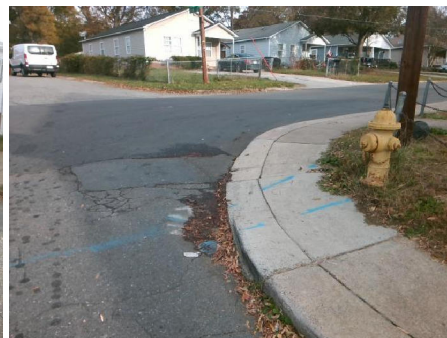
Not Found, R304.2.2, R304.5.3

Compliance	Description	Data	Compliance	Description	Data
N/A	Ramp Length (in)	38.0	No	Ramp Slope (%)	11.1
Yes	Ramp Width (in)	64.0	No	Ramp XSlope (%)	9.4
N/A	Flare Type LT	N/A	N/A	Flare Type RT	N/A
N/A	Flare Slope LT (%)	N/A	N/A	Flare Slope RT (%)	N/A
N/A	Flare Traversable LT?	N/A	N/A	Flare Traversable RT?	N/A
N/A	Landing Length (in)	N/A	N/A	DWS Provided?	N/A
N/A	Landing Width (in)	N/A	N/A	DWS Contrast?	N/A
N/A	Landing Slope (%)	N/A	N/A	DWS Length (in)	N/A
N/A	Landing X Slope (%)	N/A	N/A	DWS Full Width?	N/A
N/A	Landing Curb? (Y/N)	N/A	N/A	DWS Offset (in)	N/A
N/A	Shared Landing?	N/A			
N/A	Gutter Ponding?	Yes	N/A	Gutter Slope (%)	N/A
N/A	Gutter Lip Ht (in)	N/A	N/A	Gutter X Slope (%)	N/A
N/A	Painted X Walk1?	No	N/A	Painted X Walk2?	N/A
	X Walk 1 Direction	To W		X Walk 2 Direction	N/A
N/A	X Walk 1 Width (in)	N/A	N/A	X Walk 2 Width (in)	N/A
	X Walk 1 Slope (%)	2.1		X Walk 2 Slope (%)	N/A
	X Walk 1 X Slope (%)	9.3		X Walk 2 X Slope (%)	N/A

N/A	Ramp inside XWalk1?	N/A	N/A	Ramp inside XWalk2?	N/A
	Road Slope (%)	N/A	N/A	Clear Space?	N/A
	Road X Slope (%)	N/A	N/A	Clear Space to XWalk (in)	N/A
N/A	Any Obstructions?	N/A	N/A	Storm Grate/Utility Hazard?	N/A
	Obstruction Type			Storm Grate/Utility Type	
		N/A			N/A
		Yes		Surface Condition? (G/P)	Good

Possible Solutions:

Remove & Replace Entire Ramp.

Total Cost: \$ 1850.00
