## Access Compliance Report Public Rights-of-Way (Curb Ramps)

Intersection ID: N/A Main Street: SHASTA\_LN Cross Street: N/A Location: E

ADA ID: DCE450F60343 Ramp Type: Perp Initial Pass/Fail: Fail Overall Compliance: No Severity Score: 12.5

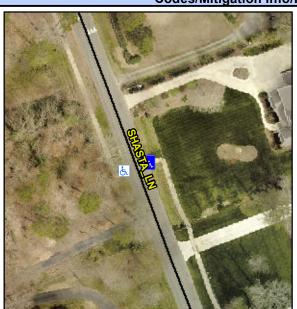
Field Measurements/Component Compliance							
Comp	liance Description	Data	Comp	oliance Description	Data		
N/A	Ramp Length (in)	122.0	No	Ramp Slope (%)	8.4		
Yes	Ramp Width (in)	59.0	Yes	Ramp XSlope (%)	2.0		
N/A	Flare Type LT	N/A	N/A	Flare Type RT	N/A		
N/A	Flare Slope LT (%)	N/A	N/A	Flare Slope RT (%)	N/A		
N/A	Flare Traversable LT?	N/A	N/A	Flare Traversable RT?	N/A		
N/A	Landing Length (in)	N/A	N/A	DWS Provided?	N/A		
N/A	Landing Width (in)	N/A	N/A	DWS Contrast?	N/A		
N/A	Landing Slope (%)	N/A	N/A	DWS Length (in)	N/A		
N/A	Landing X Slope (%)	N/A	N/A	DWS Full Width?	N/A		
N/A	Landing Curb? (Y/N)	N/A	N/A	DWS Offset (in)	N/A		
N/A	Shared Landing?	N/A					
N/A	Gutter Ponding?	N/A	N/A	Gutter Slope (%)	N/A		
N/A	Gutter Lip Ht (in)	N/A	N/A	Gutter X Slope (%)	N/A		
N/A	Painted X Walk1?	No	N/A	Painted X Walk2?	N/A		
	X Walk 1 Direction	To W		X Walk 2 Direction	N/A		
N/A	X Walk 1 Width (in)	N/A	N/A	X Walk 2 Width (in)	N/A

X Walk 1 Slope (%)	5.1		X Walk 2 Slope (%)	N/A		
	X Walk 1 X Slope (%)	2.1		X Walk 2 X Slope (%)	N/A		
N/A	Ramp inside XWalk1?	N/A	N/A	Ramp inside XWalk2?	N/A		
	Road Slope (%)	N/A	N/A	Clear Space?	N/A		
	Road X Slope (%)	N/A	N/A	Clear Space to XWalk (in)	N/A		
N/A	Any Obstructions?	N/A	N/A	Storm Grate/Utility Hazard?	N/A		
	Obstruction Type			Storm Grate/Utility Type			
		N/A			N/A		
			Yes	Surface Condition? (G/P)	Good

OSSIDIE OCIULIOII						
Possible Solutions:						
Remove & Replace Entire Ramp.						
Numrayar Mataa						
Surveyor Notes:						
N/A						
PROW/ADA:						
R304.2.2
