Access Compliance Report

Public Rights-of-Way

(Curb Ramps)

Intersection ID: 17117	Main Street: CROYDON_RD	Cross Street: ROSWELL_AV	Location: NW
ADA ID: DCE52553DC11	Ramp Type: PerpDiag	Initial Pass/Fail: Fail	Overall Compliance: No
Severity Score: 13.75			
Codes/Mitigation Info/Possible Solution		Field Measurements/Component Compliance

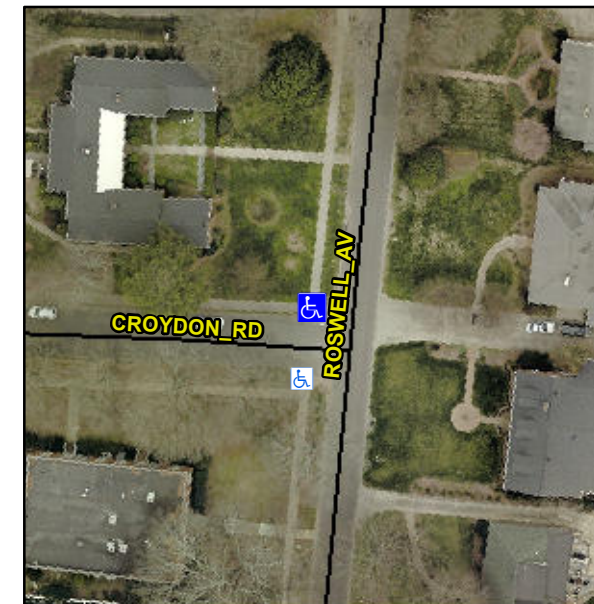
Not Found, R304.2.2, R304.5.3

Compliance	Description	Data	Compliance	Description	Data
N/A	Ramp Length (in)	43.0	No	Ramp Slope (%)	10.2
Yes	Ramp Width (in)	48.0	No	Ramp XSlope (%)	3.2
N/A	Flare Type LT	N/A	N/A	Flare Type RT	N/A
N/A	Flare Slope LT (%)	N/A	N/A	Flare Slope RT (%)	N/A
N/A	Flare Traversable LT?	N/A	N/A	Flare Traversable RT?	N/A
N/A	Landing Length (in)	N/A	N/A	DWS Provided?	N/A
N/A	Landing Width (in)	N/A	N/A	DWS Contrast?	N/A
N/A	Landing Slope (%)	N/A	N/A	DWS Length (in)	N/A
N/A	Landing X Slope (%)	N/A	N/A	DWS Full Width?	N/A
N/A	Landing Curb? (Y/N)	N/A	N/A	DWS Offset (in)	N/A
N/A	Shared Landing?	N/A			
N/A	Gutter Ponding?	N/A	N/A	Gutter Slope (%)	N/A
N/A	Gutter Lip Ht (in)	N/A	N/A	Gutter X Slope (%)	N/A
N/A	Painted X Walk1?	No	N/A	Painted X Walk2?	No
	X Walk 1 Direction	To SW		X Walk 2 Direction	To E
N/A	X Walk 1 Width (in)	N/A	N/A	X Walk 2 Width (in)	N/A
	X Walk 1 Slope (%)	5.0		X Walk 2 Slope (%)	1.3
	X Walk 1 X Slope (%)	3.2		X Walk 2 X Slope (%)	3.9

N/A	Ramp inside XWalk1?	N/A	N/A	Ramp inside XWalk2?	N/A
	Road Slope (%)	3.1	N/A	Clear Space?	N/A
	Road X Slope (%)	3.9	N/A	Clear Space to XWalk (in)	N/A
N/A	Any Obstructions?	N/A	N/A	Storm Grate/Utility Hazard?	N/A
	Obstruction Type			Storm Grate/Utility Type	
		N/A			N/A
		Yes		Surface Condition? (G/P)	Good

Remove & Replace Curb Ramp With Two New Directional Ramps or Equivalent.
