# Access Compliance Report

## Public Rights-of-Way

### (Curb Ramps)

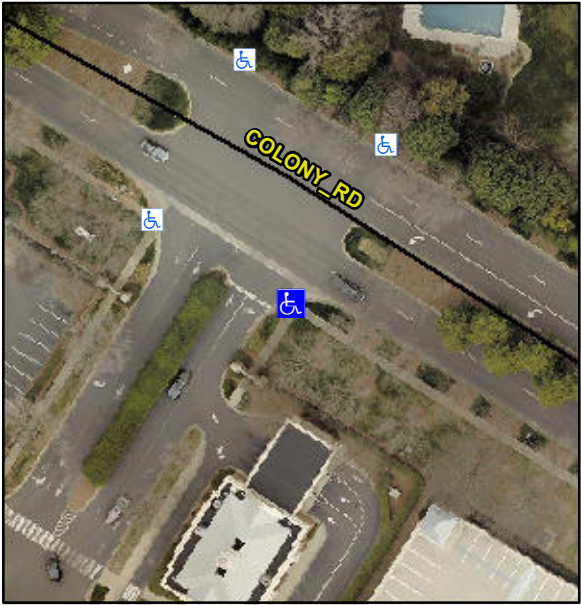
Intersection ID: 10023794	Main Street: COLONY_RD	Cross Street: N/A	Location: SE
ADA ID: DCE669D3A7A3	Ramp Type: PerpDiag	Initial Pass/Fail: Fail	Overall Compliance: No
Codes/Mitigation Info/Possible Solution		Field Measurements/Component Compliance	
Severity Score: 26.25

Possible Solutions:						
	Remove & Replace Curb Ramp With Two New Directional Ramps or Equivalent.	Compliance	Description	Data	Compliance	Description	Data
		N/A	Ramp Length (in)	35.0	No	Ramp Slope (%)	13.1
		Yes	Ramp Width (in)	48.0	No	Ramp XSlope (%)	4.8
		N/A	Flare Type LT	N/A	N/A	Flare Type RT	N/A
		N/A	Flare Slope LT (%)	N/A	N/A	Flare Slope RT (%)	N/A
		N/A	Flare Traversable LT?	N/A	N/A	Flare Traversable RT?	N/A
		N/A	Landing Length (in)	N/A	N/A	DWS Provided?	N/A
		N/A	Landing Width (in)	N/A	N/A	DWS Contrast?	N/A
		N/A	Landing Slope (%)	N/A	N/A	DWS Length (in)	N/A
<p>Surveyor Notes:</p> <p>N/A</p> <p>PROW/ADA:</p> <p>Not Found, R304.2.2, R304.5.3</p>		N/A	Landing X Slope (%)	N/A	N/A	DWS Full Width?	N/A
		N/A	Landing Curb? (Y/N)	N/A	N/A	DWS Offset (in)	N/A
		N/A	Shared Landing?	N/A			
		N/A	Gutter Ponding?	N/A	N/A	Gutter Slope (%)	N/A
		N/A	Gutter Lip Ht (in)	N/A	N/A	Gutter X Slope (%)	N/A
		N/A	Painted X Walk1?	No	N/A	Painted X Walk2?	No
