Access Compliance Report

Public Rights-of-Way

(Curb Ramps)

Intersection ID: 13994	Main Street: E_3RD_ST	Cross Street: S_TORRENCE_ST	Location: SW
ADA ID: DCEC1F207EA4	Ramp Type: Perp	Initial Pass/Fail: Fail	Overall Compliance: No
		Severity Score: 8.75

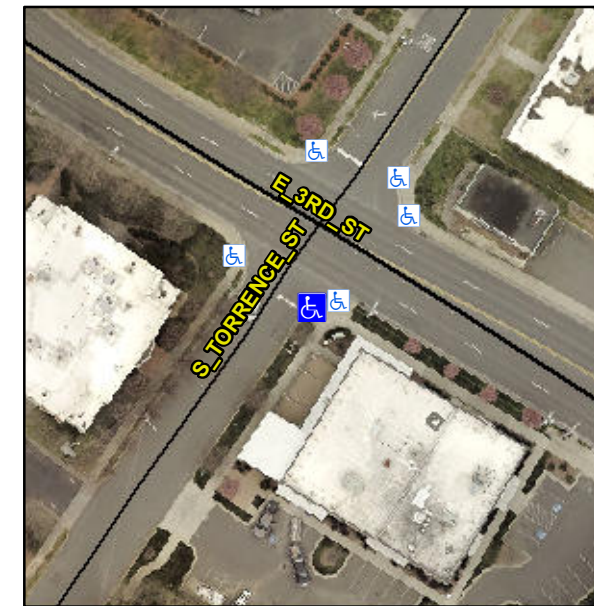
Compliance	Description	Data	Compliance	Description	Data
N/A	Ramp Length (in)	91.5	Yes	Ramp Slope (%)	7.9
No	Ramp Width (in)	37.0	Yes	Ramp XSlope (%)	0.4
N/A	Flare Type LT	N/A	N/A	Flare Type RT	N/A
N/A	Flare Slope LT (%)	N/A	N/A	Flare Slope RT (%)	N/A
N/A	Flare Traversable LT?	N/A	N/A	Flare Traversable RT?	N/A
N/A	Landing Length (in)	N/A	N/A	DWS Provided?	N/A
N/A	Landing Width (in)	N/A	N/A	DWS Contrast?	N/A
N/A	Landing Slope (%)	N/A	N/A	DWS Length (in)	N/A
N/A	Landing X Slope (%)	N/A	N/A	DWS Full Width?	N/A
N/A	Landing Curb? (Y/N)	N/A	N/A	DWS Offset (in)	N/A
N/A	Shared Landing?	N/A			
N/A	Gutter Ponding?	N/A	N/A	Gutter Slope (%)	N/A
N/A	Gutter Lip Ht (in)	1.0	N/A	Gutter X Slope (%)	N/A
N/A	Painted X Walk1?	No	N/A	Painted X Walk2?	N/A
	X Walk 1 Direction	To NW		X Walk 2 Direction	N/A
N/A	X Walk 1 Width (in)	N/A	N/A	X Walk 2 Width (in)	N/A
	X Walk 1 Slope (%)	0.8		X Walk 2 Slope (%)	N/A
	X Walk 1 X Slope (%)	1.7		X Walk 2 X Slope (%)	N/A

Possible Solutions:

Remove & Replace Entire Ramp.

PROW/ADA:

R304.5.1
