Access Compliance Report

Public Rights-of-Way

(Curb Ramps)

Intersection ID: 30064	Main Street: CAMPUS_CONNECTION_DR	Cross Street: PAVILION_BV	Location: SE
ADA ID: DCF70616F455	Ramp Type: Perp	Initial Pass/Fail: Fail	Overall Compliance: No
Codes/Mitigation Info/Possible Solution		Field Measurements/Component Compliance	
Severity Score: 46.25

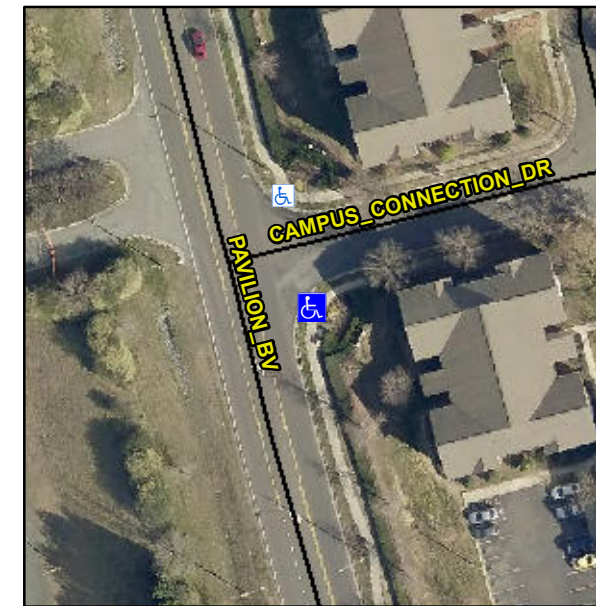
R304.5.1, R304.2.2, R304.5.3

Compliance	Description	Data	Compliance	Description	Data
N/A	Ramp Length (in)	46.0	No	Ramp Slope (%)	20.0
No	Ramp Width (in)	38.0	No	Ramp XSlope (%)	6.8
N/A	Flare Type LT	N/A	N/A	Flare Type RT	N/A
N/A	Flare Slope LT (%)	N/A	N/A	Flare Slope RT (%)	N/A
N/A	Flare Traversable LT?	N/A	N/A	Flare Traversable RT?	N/A
N/A	Landing Length (in)	N/A	N/A	DWS Provided?	N/A
N/A	Landing Width (in)	N/A	N/A	DWS Contrast?	N/A
N/A	Landing Slope (%)	N/A	N/A	DWS Length (in)	N/A
N/A	Landing X Slope (%)	N/A	N/A	DWS Full Width?	N/A
N/A	Landing Curb? (Y/N)	N/A	N/A	DWS Offset (in)	N/A
N/A	Shared Landing?	N/A			
N/A	Gutter Ponding?	N/A	N/A	Gutter Slope (%)	N/A
N/A	Gutter Lip Ht (in)	N/A	N/A	Gutter X Slope (%)	N/A
N/A	Painted X Walk1?	No	N/A	Painted X Walk2?	N/A
	X Walk 1 Direction	To N		X Walk 2 Direction	N/A
N/A	X Walk 1 Width (in)	N/A	N/A	X Walk 2 Width (in)	N/A
	X Walk 1 Slope (%)	1.5		X Walk 2 Slope (%)	N/A
	X Walk 1 X Slope (%)	8.9		X Walk 2 X Slope (%)	N/A

N/A	Ramp inside XWalk1?	N/A	N/A	Ramp inside XWalk2?	N/A
	Road Slope (%)	N/A	N/A	Clear Space?	N/A
	Road X Slope (%)	N/A	N/A	Clear Space to XWalk (in)	N/A
N/A	Any Obstructions?	N/A	N/A	Storm Grate/Utility Hazard?	N/A
	Obstruction Type			Storm Grate/Utility Type	
		N/A			N/A
			Yes	Surface Condition? (G/P)	Good

Remove & Replace Entire Ramp.
